VEHICLE INSPECTION REPORT

HT23VYD

Ford Transit 350 2.0 EcoBlue 130PS

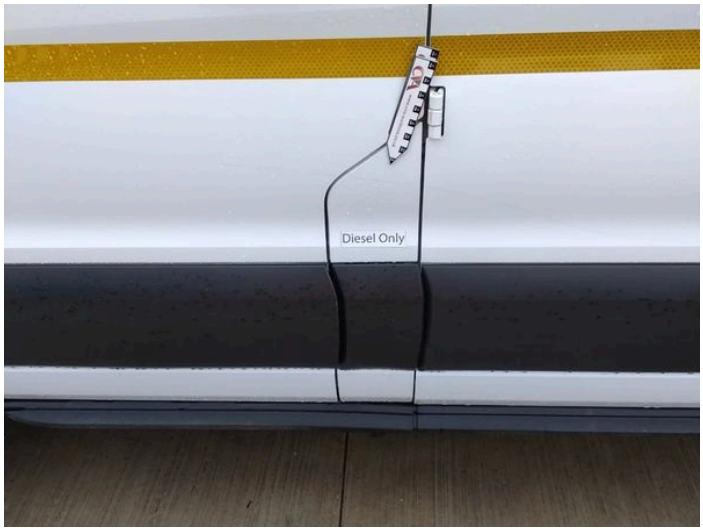
1: Bonnet
Chipped
Over 5mm

2: Bumper Front
Scratched
Over 100mm Thru Paint

3: Bumper Front
Scratched
Over 100mm Thru Paint

4: Door Mirror Assy nsf
Broken
Replace

5: Wheel nsf
Corroded
Light

6: Wing nsf
Scratched
Over 25mm Not Thru Paint

7: A Post ns
Scratched
Over 25mm Not Thru Paint

8: Door nsf
Chipped
Over 5mm

9: Door nsf
Chipped
Edge Chip

10: Door nsf
Scratched
Over 25mm Not Thru Paint

11: Fuel Flap
Scratched
Over 25mm Not Thru Paint

12: Door nsr
Scratched
Over 25mm Not Thru Paint

13: Door Moulding nsr
Scuffed (Unpainted)
Over 100mm

14: Door nsr
Scratched
Over 25mm Thru Paint

15: D Post ns
Chipped
Over 5mm

16: D Post ns
Scratched
Over 25mm Not Thru Paint

17: D Post os
Scratched
Over 25mm Not Thru Paint

18: D Post os
Chipped
Over 5mm

19: Door osr
Chipped
Over 5mm

20: Door osf
Chipped
Over 5mm

21: Door osf
Scratched
Over 25mm Not Thru Paint

22: Sill os
Dented
With Paint Damage

23: Door Mirror Assy osf
Scuffed (Unpainted)
Over 100mm

24: Bumper Front
Scratched
Over 25mm Not Thru Paint

25: Bumper Front
Scratched
Over 25mm Not Thru Paint

26: Headrest Assy osf
Missing
Replace
