VEHICLE INSPECTION REPORT

WG71VNV

Ford Ranger Wildtrak 2.0 EcoBlue 213

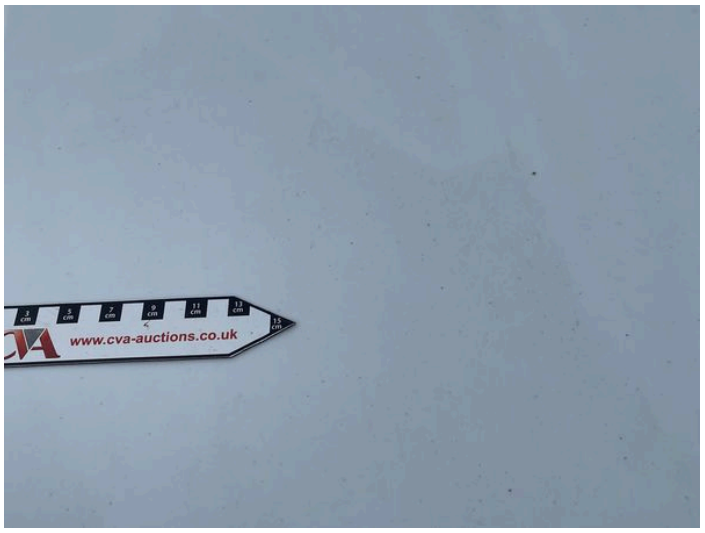
1: Bonnet
Chipped
Multiple Chips

2: Bumper Front
Scratched
Over 100mm Thru Paint

3: Door osf
Dented
With Paint Damage

4: Qtr Panel nsr
Dented
Over 30mm
