VEHICLE INSPECTION REPORT

BL73AVN

Ford Transit 350 2.0 ECOBLUE130PS LEADER

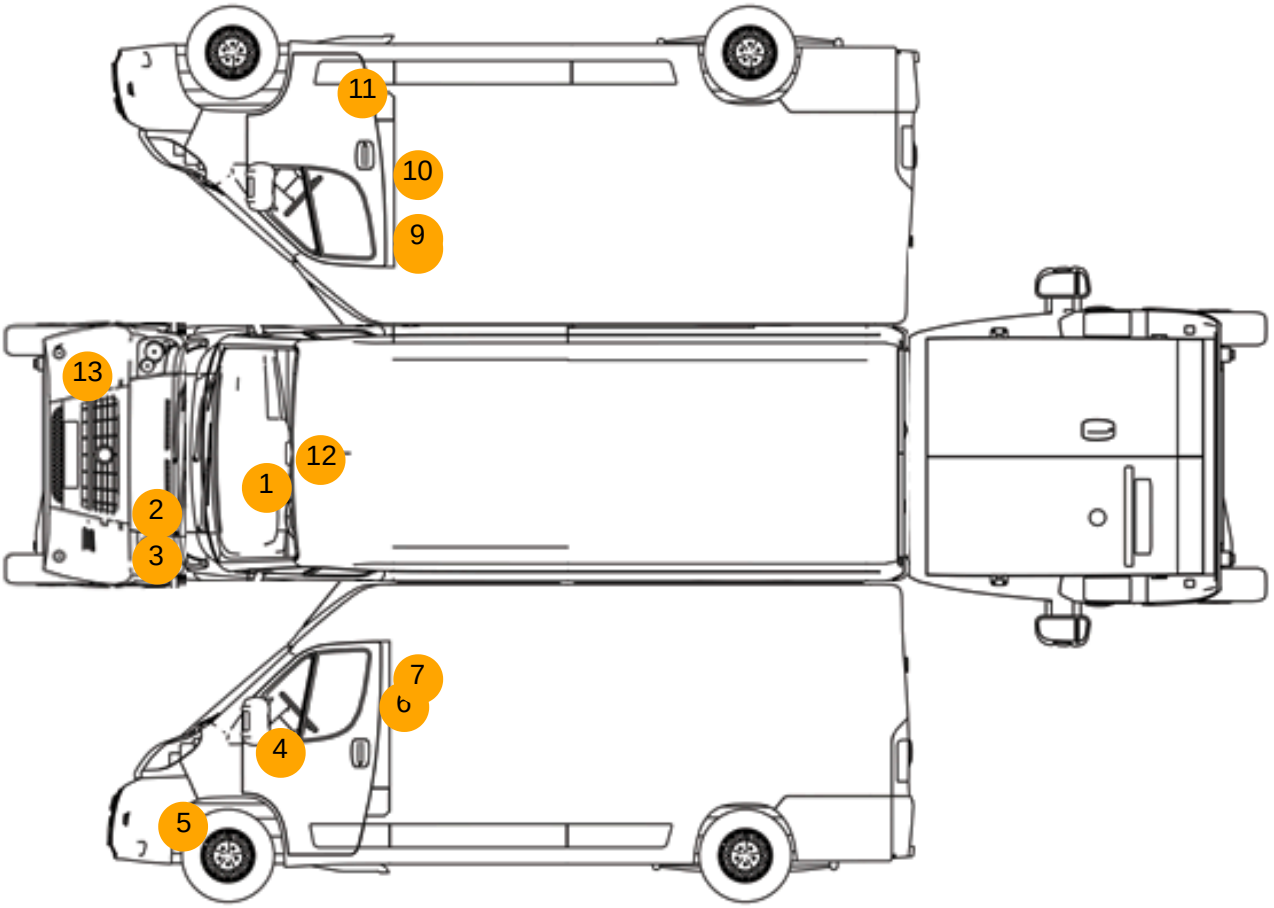
1: Screen Front
Cracked
Replace

2: Bonnet
Chipped
Over 5mm

3: Bumper Front
Scratched
Over 25mm Not Thru Paint

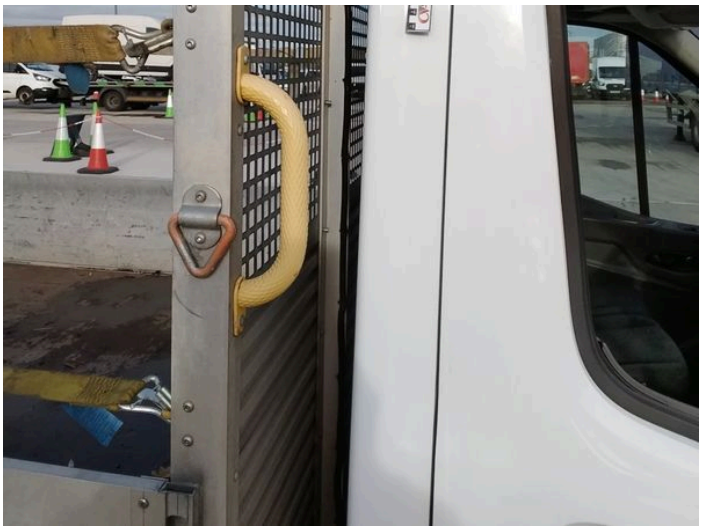
7: B Post ns
Scratched
Over 25mm Not Thru Paint

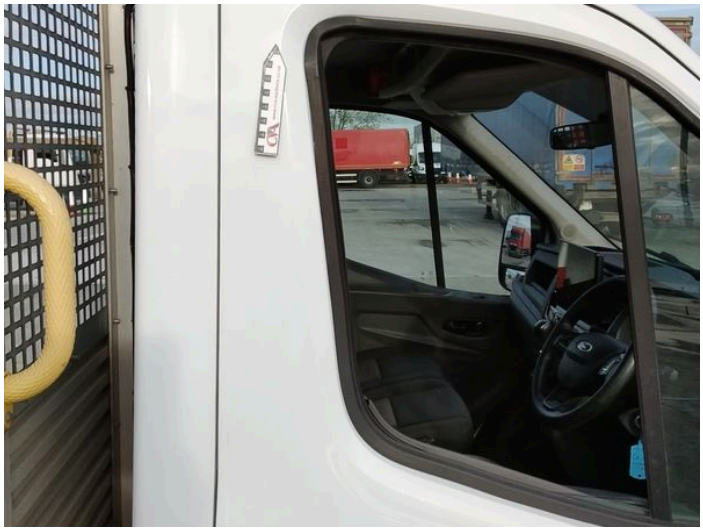
8: B Post os
Scratched
Over 25mm Not Thru Paint

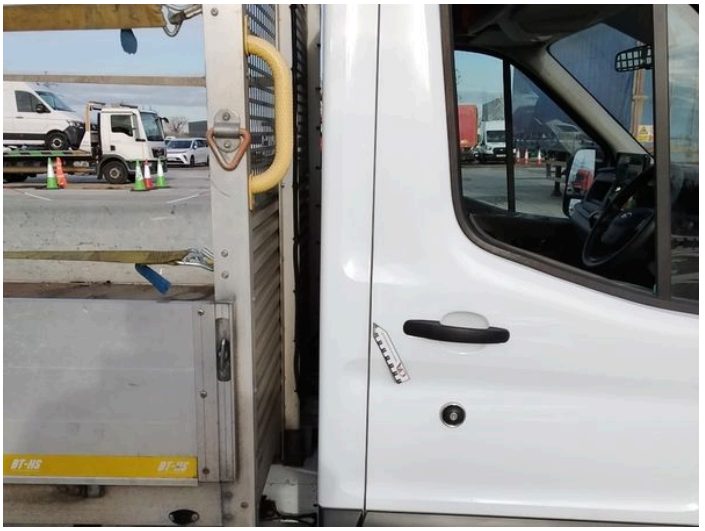
9: Door osf
Scratched
Over 25mm Not Thru Paint

10: Door osf
Chipped
Over 5mm

11: Door Moulding osf
Scuffed (Unpainted)
Over 100mm

12: Roof
Chipped
Over 5mm

13: Bumper Front
Scratched
Over 25mm Not Thru Paint

14: Seat Base Cover nsf
Holed
Over 3mm
