VEHICLE INSPECTION REPORT

HG23DDZ

Ford / Roller Team AUTO ROLLER 747 2.0 ECOBLUE

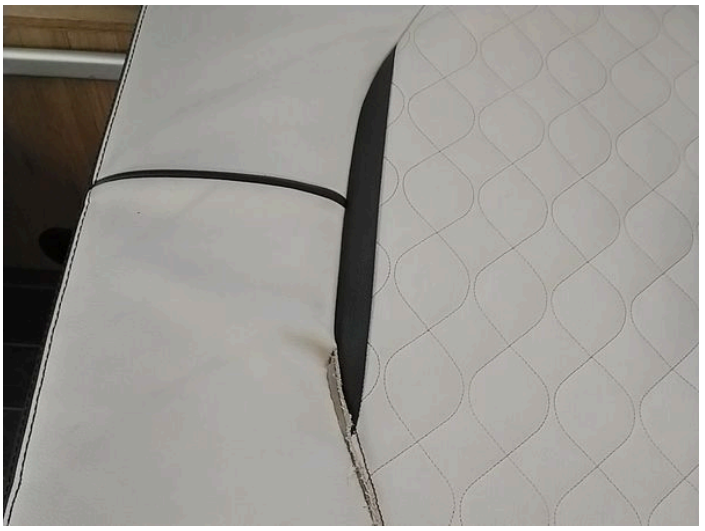
1: Door Mirror Assy nsf
Scuffed (Unpainted)
UpTo 100mm

2: Flasher Side Repeater os
Broken
Replace

3: Door Mirror Glass os
Missing
Replace

4: Qtr Panel osr
Scratched
Over 25mm Not Thru Paint

5: Qtr Panel nsr
Scratched
Over 25mm Not Thru Paint

6: Bumper Front
Scratched
UpTo 25mm Not Thru Paint

7: Seat Base Cover osf
Holed
Over 3mm

8: Seat Base Cover nsr
Torn
Over 3mm
