VEHICLE INSPECTION REPORT

PO71LLK

Fiat Ducato Maxi 35 2.2 MULTIJET 140PS

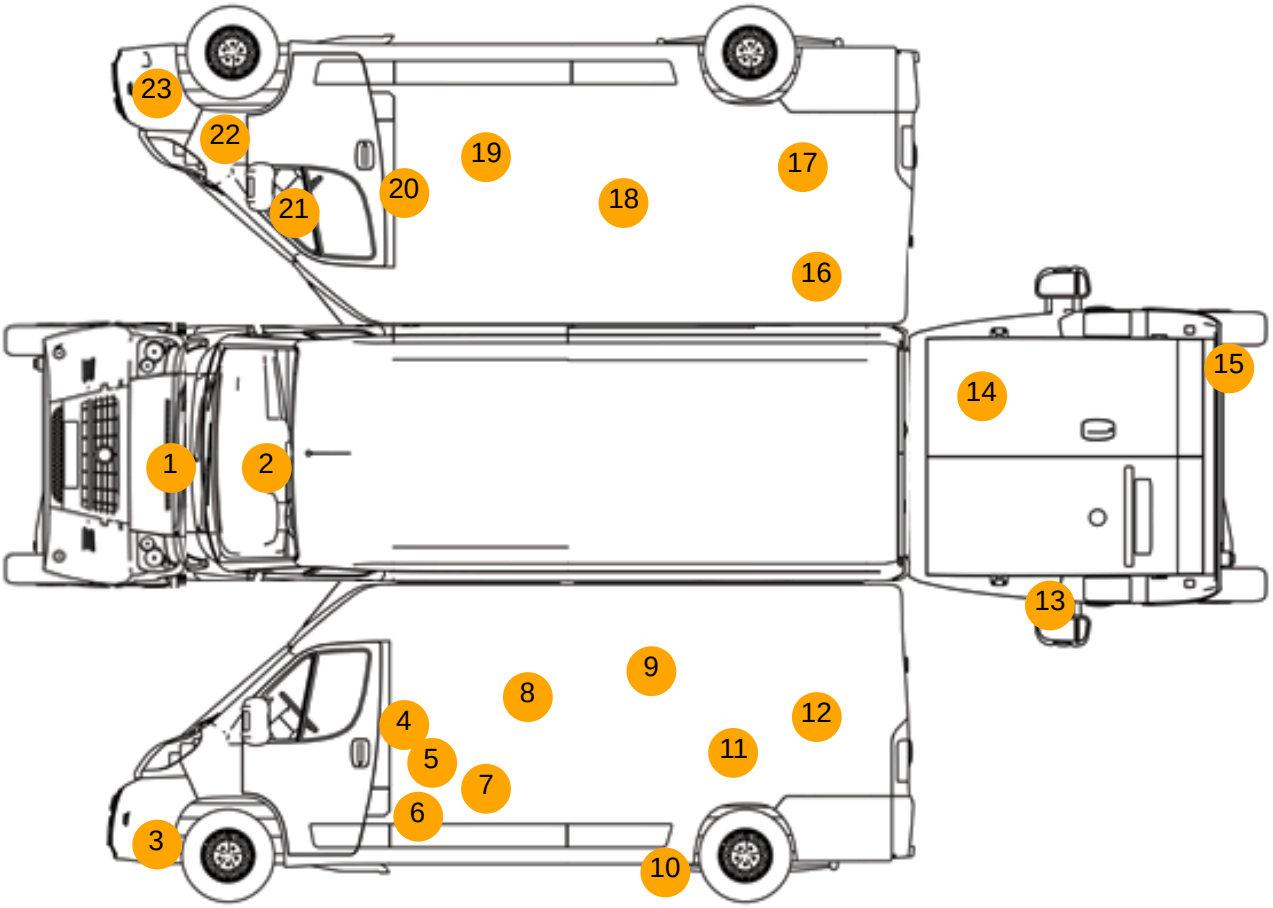
Condition Check

NON-RUNNER-TURNS OVER DOES NOT START, PISTONS SEIZED, AD BLUE, SIDE LOAD DOOR, E/MIRRORS

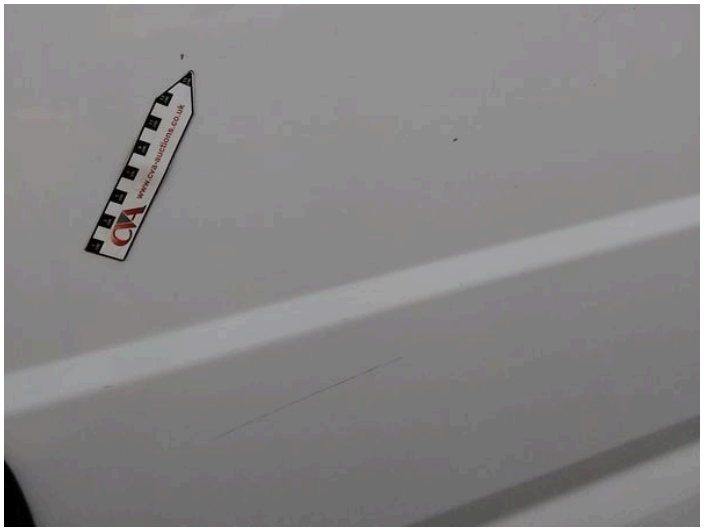
1: Bonnet
Chipped
Multiple Chips

2: Screen Front
Cracked
Replace

3: Bumper Front
Scratched
Over 100mm Thru Paint

4: Door nsf
Scratched
Over 25mm Thru Paint

5: Qtr Panel nsr
Chipped
Multiple Chips

6: Qtr Panel nsr
Dented
Between 10mm + 30mm

7: Qtr Panel nsr
Dented
Between 10mm + 30mm

8: Qtr Panel nsr
Poor Previous Repair
Rippled Over 30%

9: Qtr Panel nsr
Poor Previous Repair
Rippled Over 30%

10: Sill ns
Dented
Hail - Severe

11: Qtr Panel nsr
Dented
Hail - Moderate

12: Qtr Panel nsr
Chipped
1 To 5

13: D Post ns
Dented
With Paint Damage

14: Tailgate
Dented
Hail - Moderate

15: Bumper Rear
Cracked
Over 25mm

16: Qtr Panel osr
Scratched
Over 25mm Thru Paint

17: Qtr Panel osr
Dented
Between 10mm + 30mm

18: Qtr Panel osr
Dented
Between 10mm + 30mm

19: Qtr Panel osr
Scratched
Over 25mm Thru Paint

20: Door osf
Chipped
Multiple Chips

21: Door Mirror Assy osf
Broken
Replace

22: Wing osf
Scratched
Over 25mm Thru Paint

23: Bumper Front
Cracked
Over 25mm

24: Carpets Front
Holed
Over 3mm

25: Centre Console Front
Holed
UpTo 3mm
