VEHICLE INSPECTION REPORT

BG24MHX

Ford Transit 350 2.0 EcoBlue 130PS

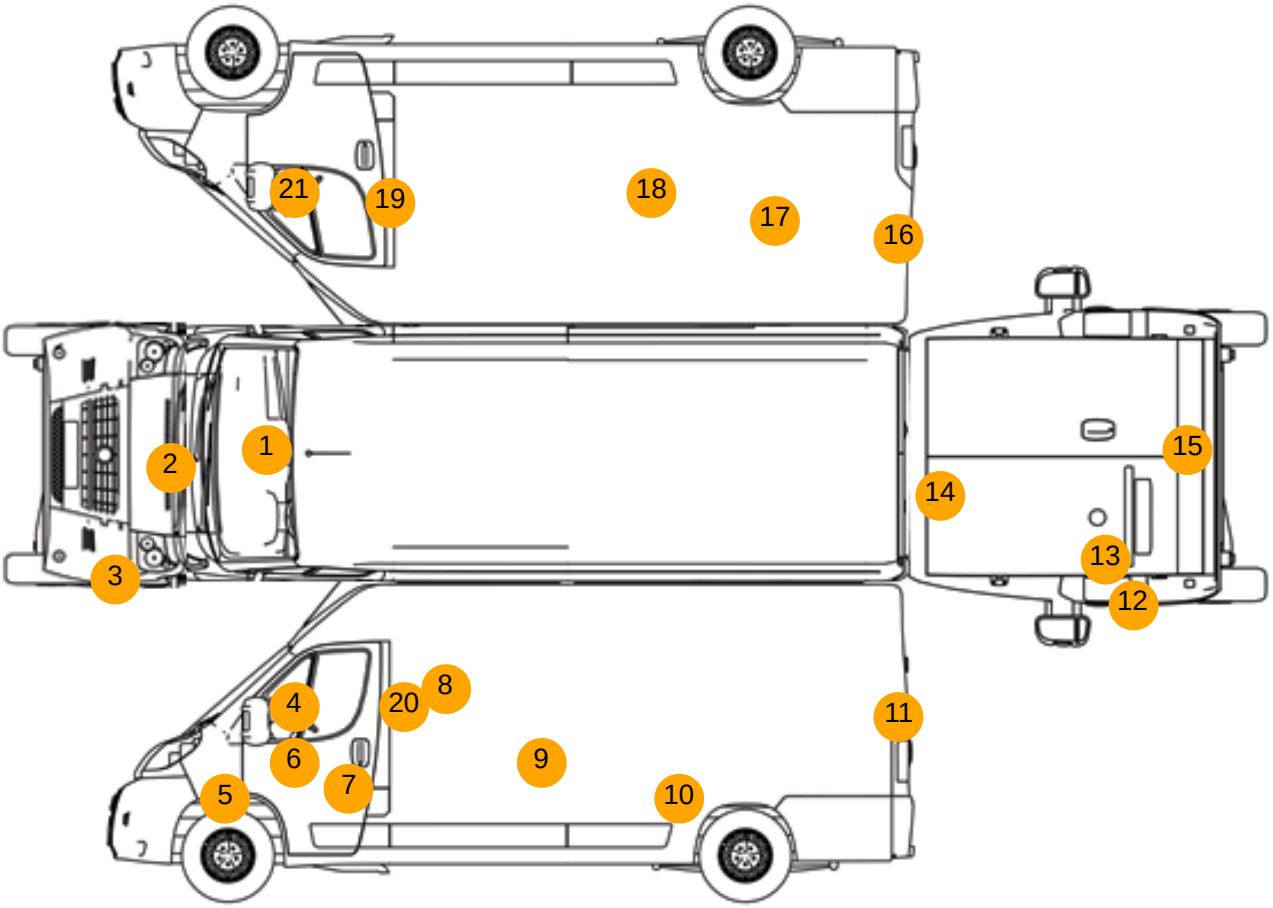
1: Screen Front
Chipped
Over 10mm

2: Bonnet
Scratched
Over 25mm Not Thru Paint

3: Bumper Front
Scratched
Over 100mm Thru Paint

4: A Post ns
Scratched
Over 25mm Not Thru Paint

5: Wing nsf
Scratched
Over 25mm Not Thru Paint

6: Door Mirror Assy nsf
Scuffed (Unpainted)
Over 100mm

7: Door nsf
Scratched
Over 25mm Not Thru Paint

8: Door nsr
Chipped
Over 5mm

9: Door nsr
Scratched
Over 25mm Not Thru Paint

10: Qtr Panel nsr
Scratched
Over 25mm Not Thru Paint

11: Qtr Panel nsr
Scratched
Over 25mm Not Thru Paint

12: Lamp nsr
Broken
Replace

13: Tailgate
Dented
Over 30mm

14: Roof
Dented
Over 30mm

15: Tailgate
Dented
With Paint Damage

16: Qtr Panel osr
Scratched
Over 25mm Not Thru Paint

17: Qtr Panel osr
Scratched
Over 25mm Not Thru Paint

18: Qtr Panel osr
Dented
With Paint Damage

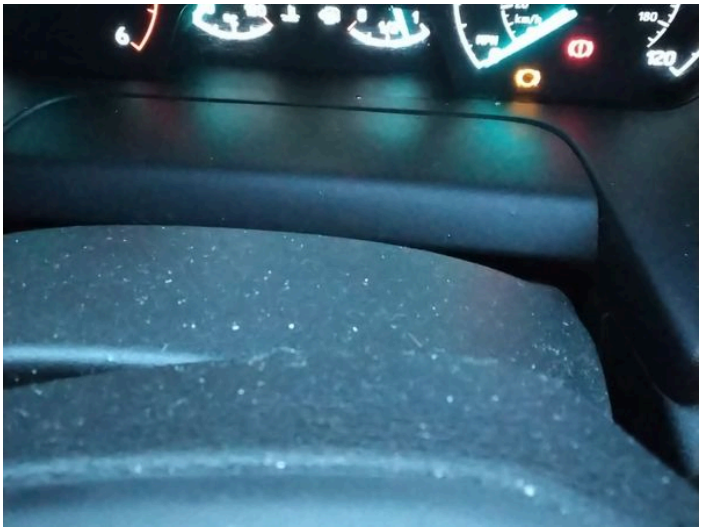
19: Door osf
Chipped
Over 5mm

20: Door nsf
Scratched
Over 25mm Not Thru Paint

21: Door Mirror Assy osf
Broken
Replace

22: Dash Warning Lights
Displayed
No Action
