VEHICLE INSPECTION REPORT

PN72BKX

Fiat Ducato 35 2.2 MULTIJET 120PS

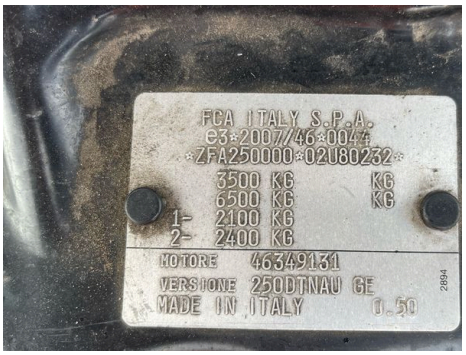
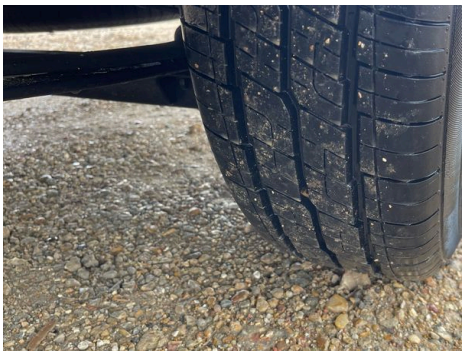
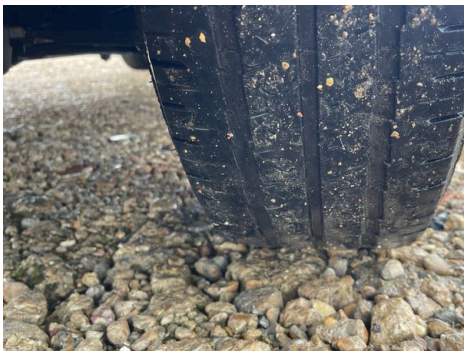
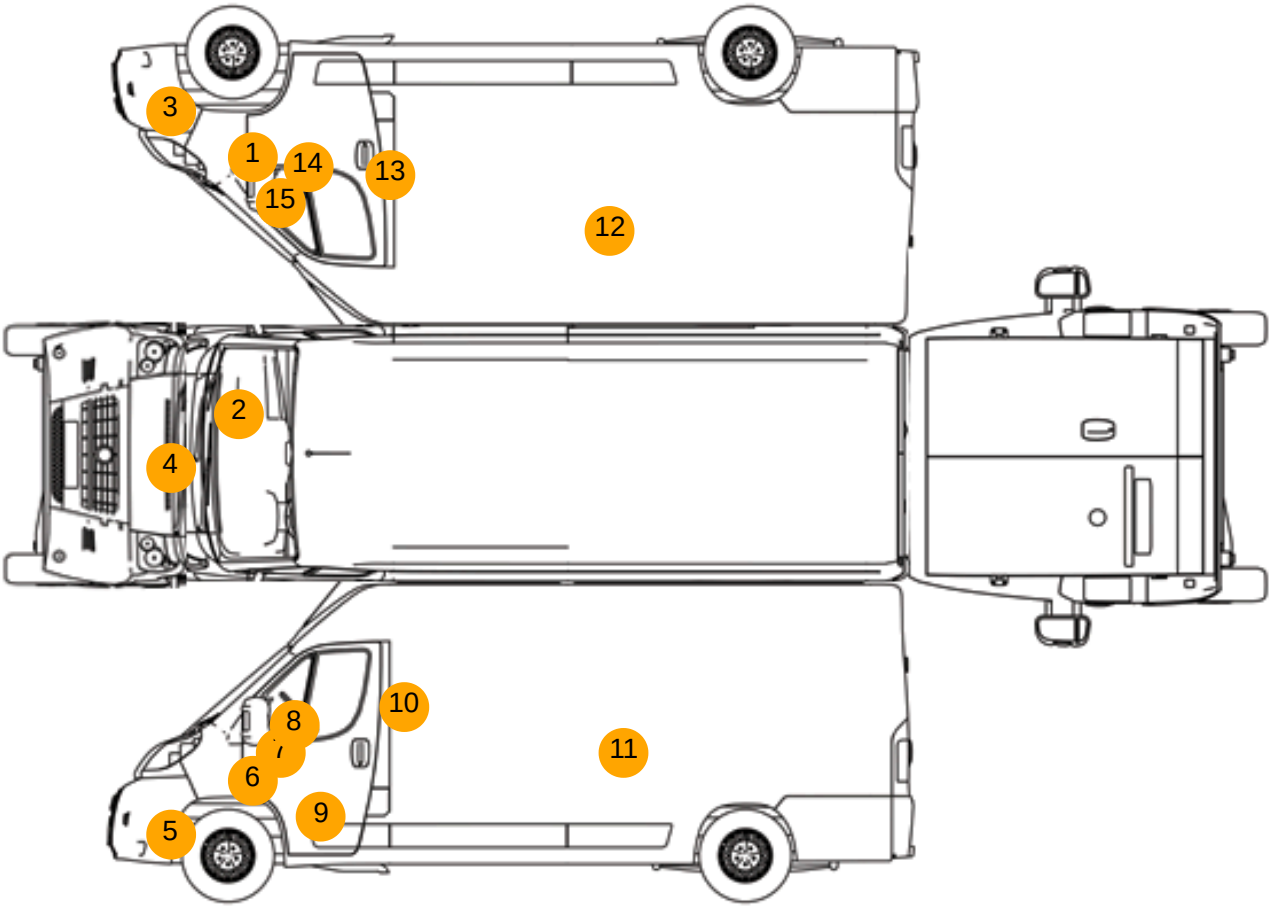
NEEDS NEW TURBO, TAIL LIFT IN-OP E/MIRRORS
