VEHICLE INSPECTION REPORT

DK67VZT

Man TGM 18.250

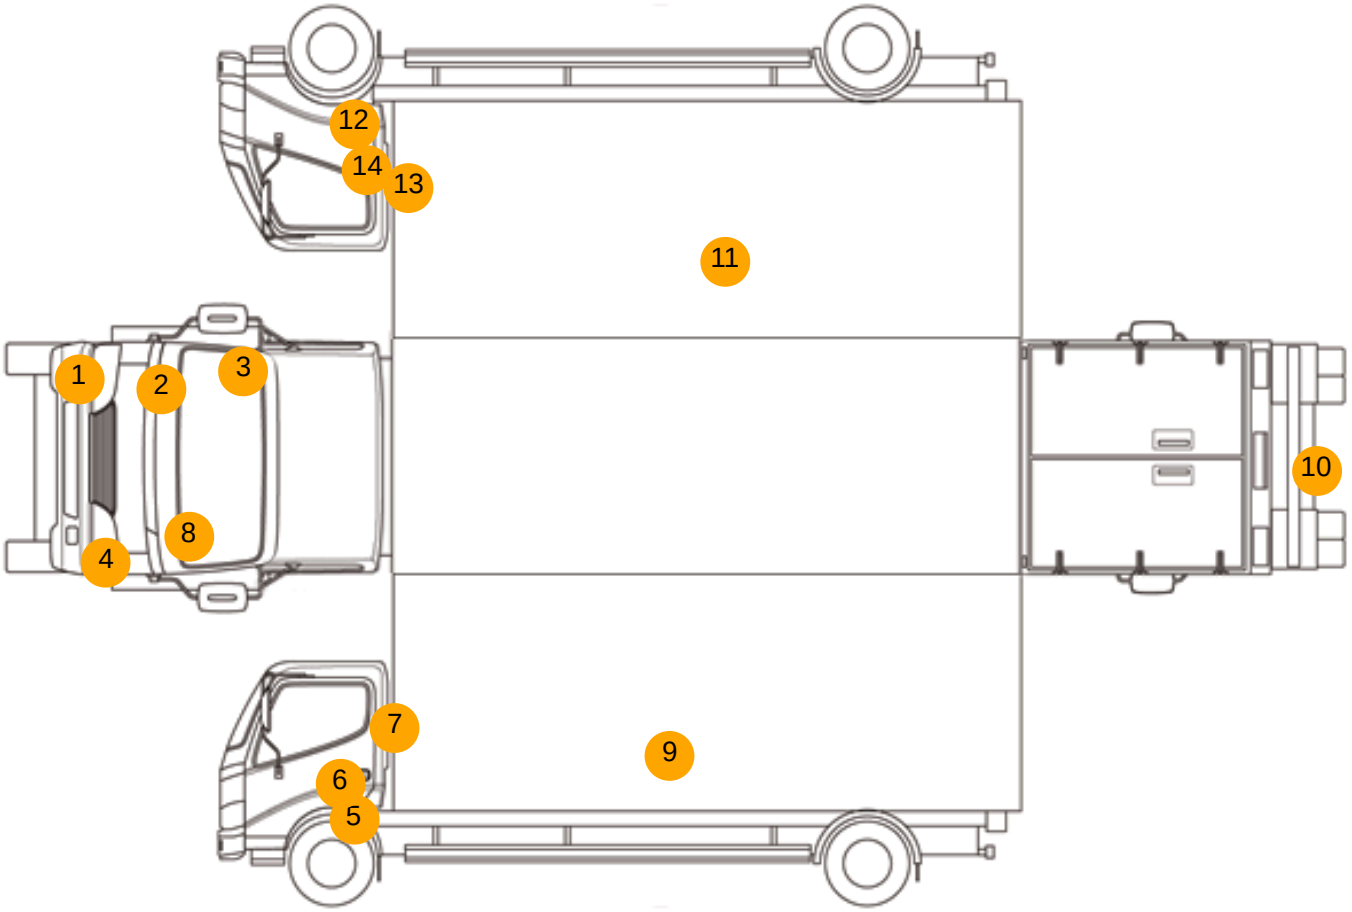
Damage Photos

1: Bumper Front Moulding
Scuffed (Unpainted)
Over 100mm

2: Wing osf
Cracked
Replace

3: A Post os
Scratched
UpTo 25mm Thru Paint

4: Bumper Front Moulding
Scuffed (Unpainted)
Over 100mm

5: Wing Front Arch Extension ns
Scuffed (Unpainted)
Over 100mm

6: Door nsf
Scratched
Over 25mm Not Thru Paint

7: Door nsf
Chipped
Edge Chip

8: Wing nsf
Poor Previous Repair
Poor Colour

9: Qtr Panel nsr
Scratched
Over 25mm Thru Paint

10: Bumper Rear
Rusted
Over 5mm

11: Qtr Panel osr
Scratched
Over 25mm Thru Paint

12: Wing Front Arch Extension os
Scuffed (Unpainted)
Over 100mm

13: Door osf
Chipped
Edge Chip

14: Door osf
Scratched
Over 25mm Not Thru Paint

15: Seat Base Cover osf
Holed
Over 3mm

16: Switches And Controls
Broken
Replace
