COMMERCIAL VEHICLE AUCTIONS LTD
THE UK'S MOST ESTABLISHED COMMERCIAL VEHICLE AUCTIONEERS

VEHICLE INSPECTION REPORT

LG24NAC

Citroen Relay 35 2.2 BlueHDI 140

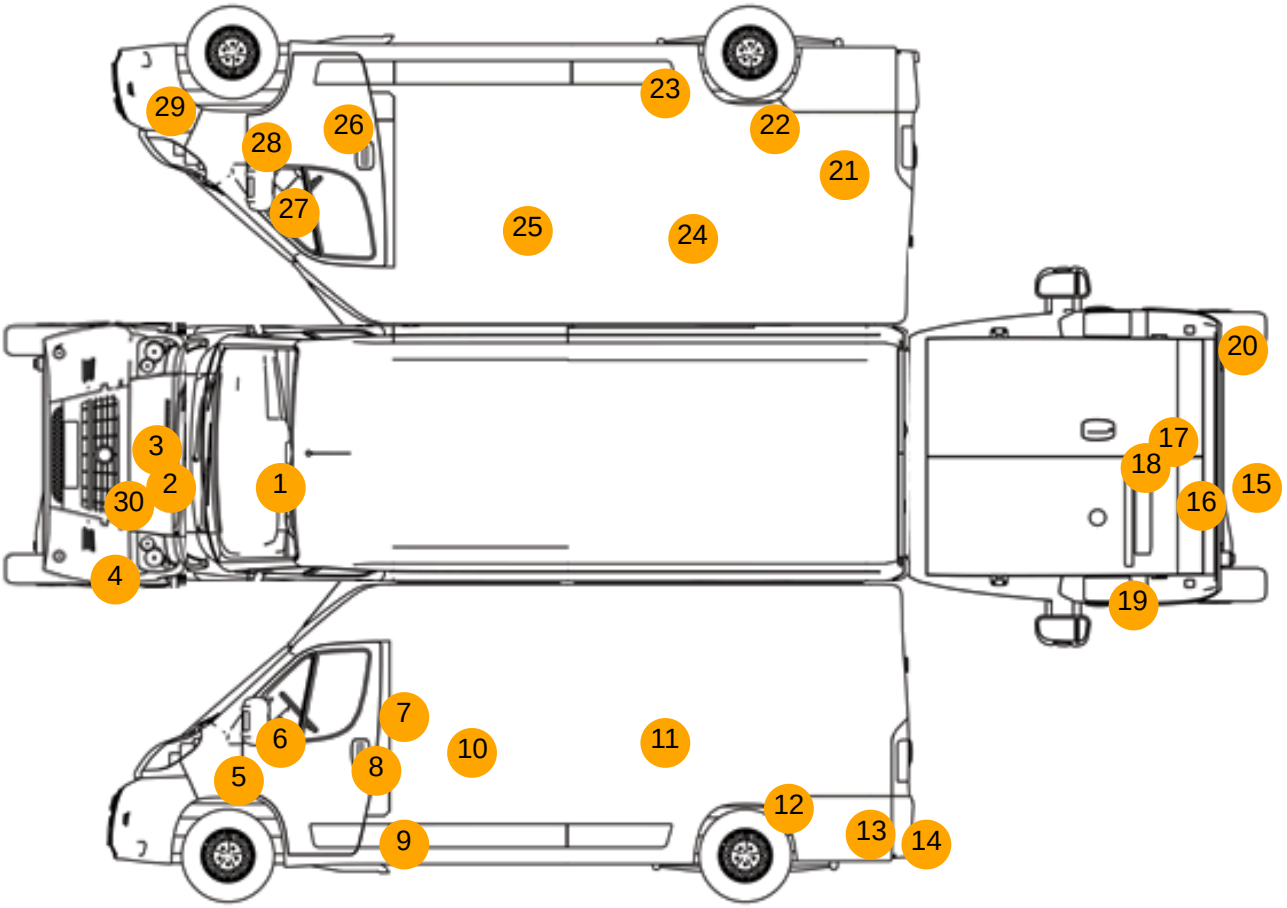
Damage Photos

1: Screen Front
Chipped
Over 10mm

2: Bonnet
Chipped
Over 5mm

3: Bonnet
Dented
Over 30mm

4: Bumper Front
Cracked
Over 25mm

5: Wing nsf
Chipped
Over 5mm

6: Door Mirror Assy nsf
Broken
Replace

7: Door nsf
Scratched
Over 25mm Thru Paint

8: Door nsf
Chipped
Over 5mm

9: B Post ns
Missing
Replace

10: Door nsr
Chipped
Over 5mm

11: Qtr Panel nsr
Scratched
Over 25mm Not Thru Paint

12: Qtr Panel Arch Extension ns
Scuffed (Unpainted)
Over 100mm

13: Qtr Panel Moulding ns
Broken
Replace

14: Bumper Rear
Hole
Over 25mm

15: Bumper Rear
Missing
Replace

16: Tailgate
Dented
Over 30mm

17: Tailgate
Dented
Over 30mm

18: Tailgate
Chipped
Edge Chip

19: Lamp nsr
Broken
Replace

20: Bumper Rear
Hole
Over 25mm

21: Qtr Panel osr
Scratched
Over 25mm Not Thru Paint

22: Qtr Panel Arch Extension os
Scuffed (Unpainted)
Over 100mm

23: Qtr Panel Moulding os
Scuffed (Unpainted)
Over 100mm

24: Qtr Panel osr
Chipped
Over 5mm

25: Qtr Panel osr
Dented
With Paint Damage

26: Door osf
Dented
With Paint Damage

27: Door Mirror Assy osf
Scuffed (Unpainted)
Over 100mm

28: Wing osf
Missing
Replace

29: Bumper Front
Scratched
Over 25mm Not Thru Paint

30: Grille Front
Broken
Replace

31: Door Pad osf
Broken
Replace

32: Seat Base Cover osf
Scuffed
Over 25mm
