VEHICLE INSPECTION REPORT

MF23CKA

IVECO DAILY 35-140

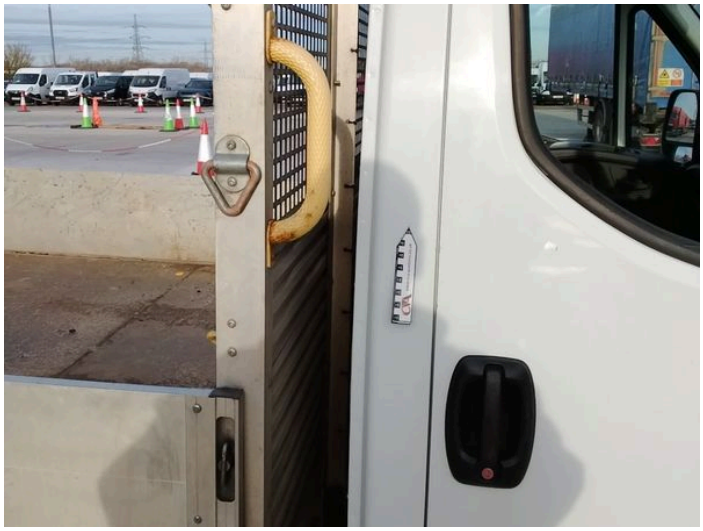
Damage Photos

1: Screen Front
Chipped
Over 10mm

2: Bonnet
Chipped
Over 5mm

3: Bumper Front
Scratched
Over 25mm Not Thru Paint

4: Door Mirror Assy nsf
Scuffed (Unpainted)
Over 100mm

5: Wing nsf
Scratched
Over 25mm Not Thru Paint

6: Wheel nsf
Corroded
Light

7: Door nsf
Chipped
Over 5mm

8: Wheel nsr
Corroded
Light

9: Bumper Rear
Rusted
Over 5mm

10: Wheel osr
Corroded
Light

11: B Post os
Chipped
Over 5mm

12: Door osf
Chipped
Over 5mm

13: Door Moulding osf
Scuffed (Unpainted)
Over 100mm

14: Wheel osf
Corroded
Light

15: Door Mirror Assy osf
Scuffed (Unpainted)
Over 100mm

16: Bumper Front
Chipped
Over 5mm

17: Bonnet
Chipped
Over 5mm
