VEHICLE INSPECTION REPORT

PJ67WMF

Daf CF 450

Non Runner

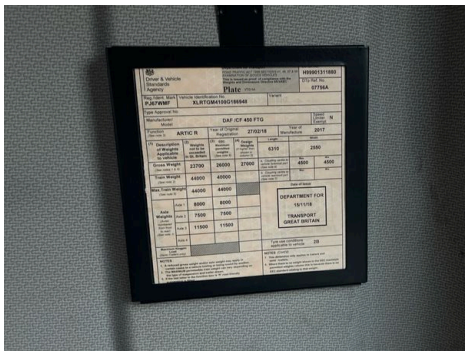
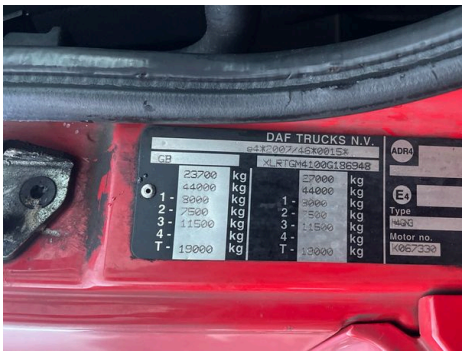
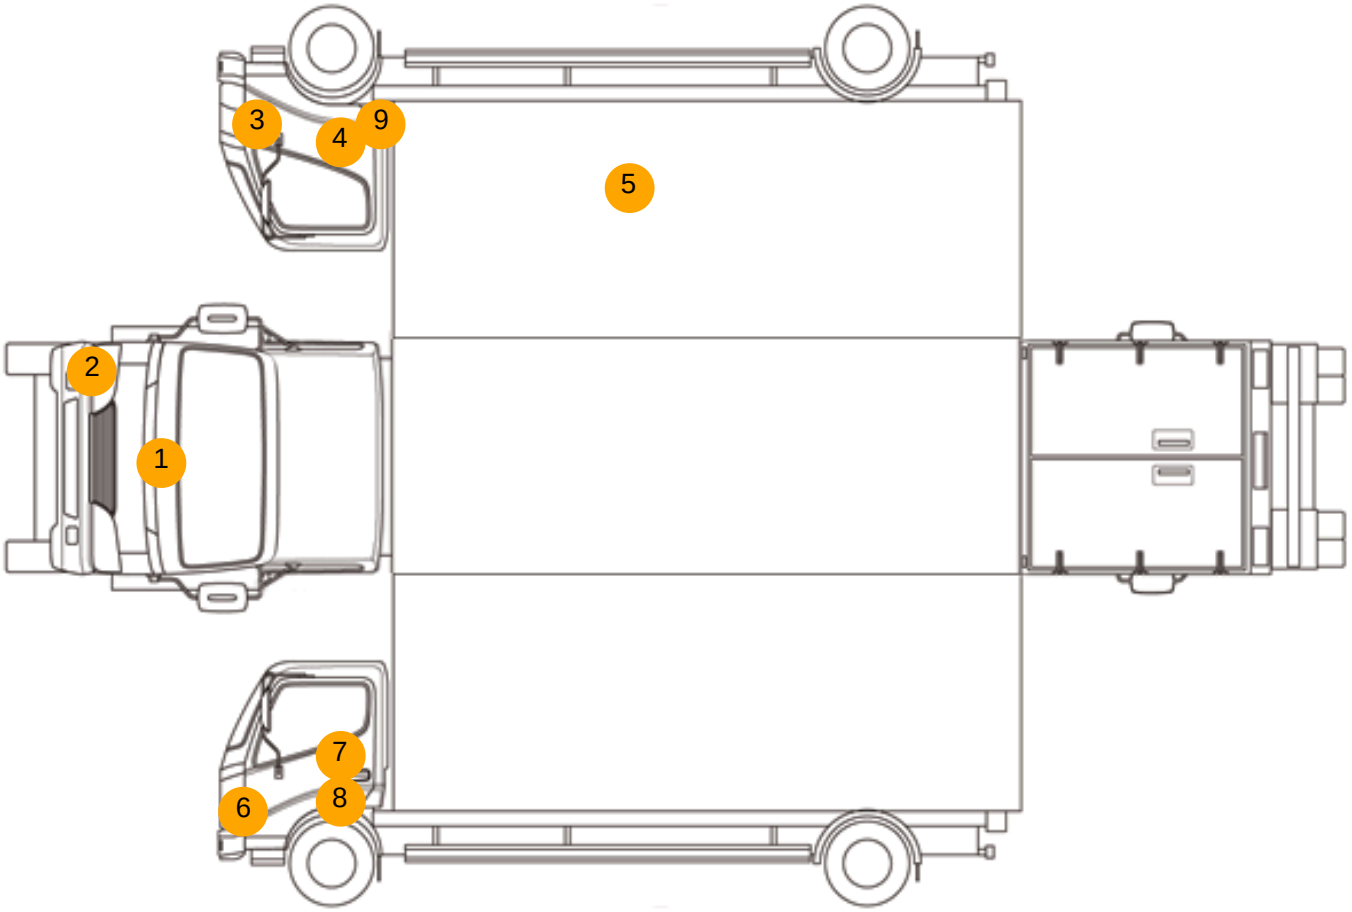
NON-RUNNER- GEAR BOX STRIPPED, SEVERE OIL LEAK - GASKET SET, TURBO, FLEXI PIPES, EGR VALVE & HARNESS REQUIRE ATTENTION
