VEHICLE INSPECTION REPORT

SF23PZM

Fiat Ducato 2.2 MULTIJET 140PS BUSINESS

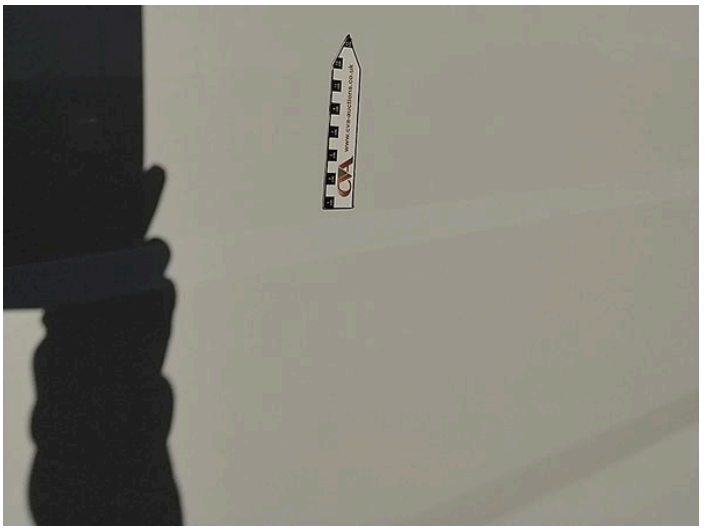
1: Bumper Front Moulding
Scuffed (Unpainted)
Over 100mm

2: Bonnet
Chipped
Multiple Chips

3: Roof
Dented
Between 10mm + 30mm

4: Bumper Front Moulding
Scuffed (Unpainted)
Over 100mm

5: Door Mirror Assy nsf
Scuffed (Unpainted)
UpTo 100mm

6: Bumper Rear Moulding
Scuffed (Unpainted)
Over 100mm

7: Qtr Panel osr
Scratched
UpTo 25mm Thru Paint

8: Qtr Panel osr
Dented
With Paint Damage

9: Door Mirror Assy osf
Scuffed (Unpainted)
UpTo 100mm

10: Carpets Front
Holed
Over 3mm
