VEHICLE INSPECTION REPORT

SF23RCY

Fiat Ducato 2.2 MULTIJET 140PS BUSINESS

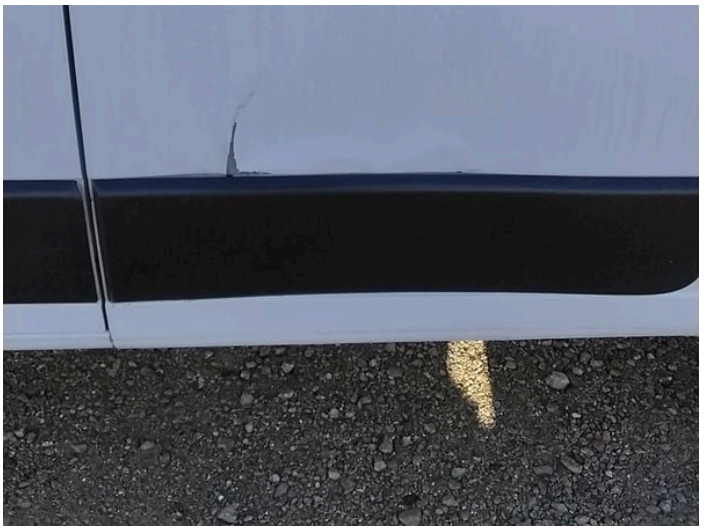
3: Bumper Front Moulding
Scuffed (Unpainted)
UpTo 100mm

4: Door Mirror Assy nsf
Scuffed (Unpainted)
UpTo 100mm

5: Door nsr
Dented
With Paint Damage

6: Door nsr
Scratched
Over 25mm Thru Paint
