VEHICLE INSPECTION REPORT

EA71WNC

Ford Transit Custom 300 2.0 ECOBLUE 130PS LEADER

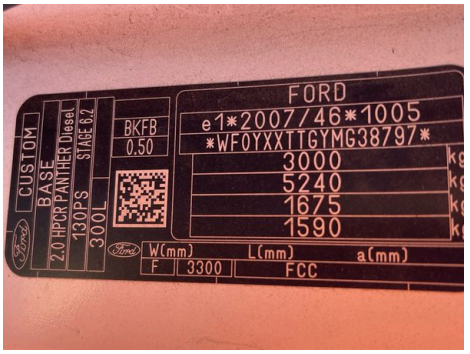
NON RUNNER-DOES NOT POWER UP, PARTS STRIPPED GAH UNIT, SIDE LOADING DOOR, MOT SHOWS 63,813 MILES 07/01/2026

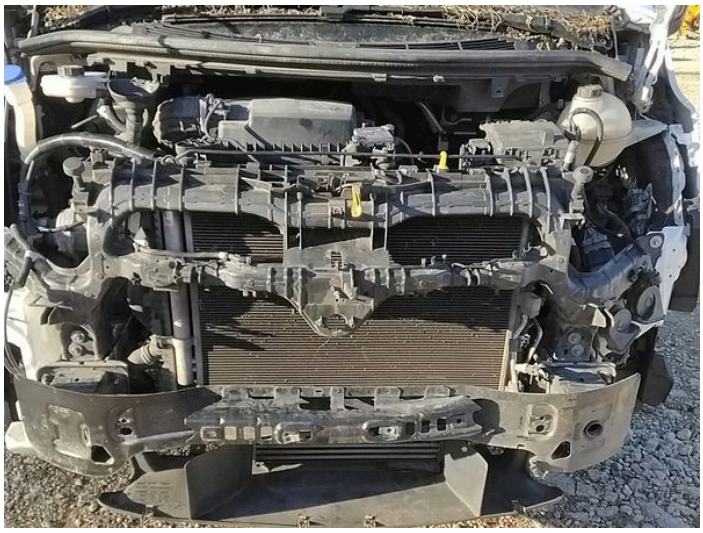
Damage Photos

1: Bonnet
Missing
Replace

2: Bumper Front
Missing
Replace

3: Grille Front
Missing
Replace

4: Headlamp os
Missing
Replace

5: Headlamp ns
Missing
Replace

6: Door Mirror Assy nsf
Scuffed (Unpainted)
UpTo 100mm

7: Door nsr
Dented
With Paint Damage

8: Qtr Panel nsr
Dented
With Paint Damage

9: Bumper Rear
Hole
UpTo 25mm

10: Qtr Panel osr
Scratched
Over 25mm Not Thru Paint

11: Door Mirror Assy osf
Scuffed (Unpainted)
UpTo 100mm
