VEHICLE INSPECTION REPORT

EA71WNE

Ford Transit Custom 300 2.0 ECOBLUE 130PS LEADER

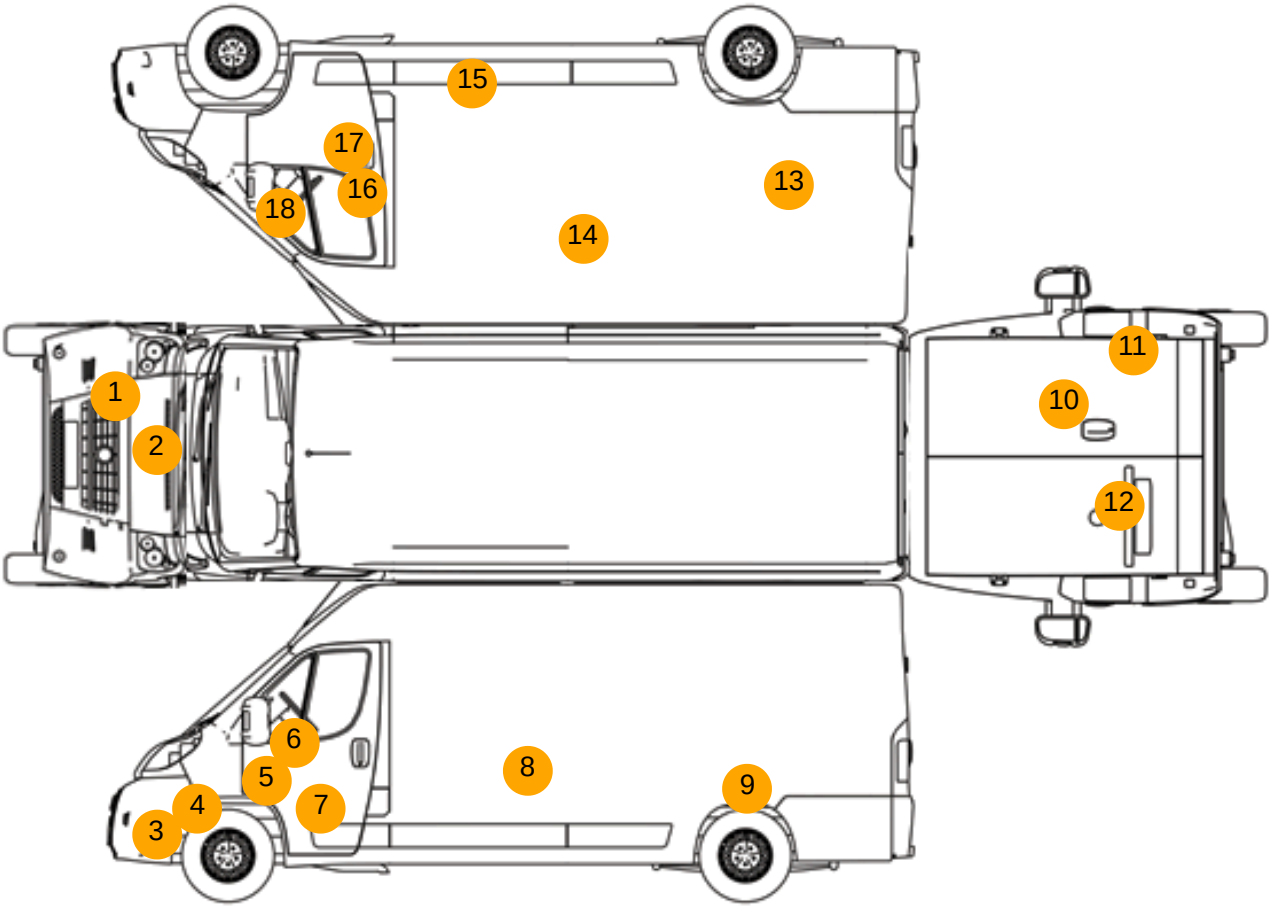
ONLY RUNS WITH JUMP PACK ATTACHED, ENGINE KNOCKING GAH UNIT, SIDE LOADING DOOR
