VEHICLE INSPECTION REPORT

SA71KJO

Fiat Doblo 1.6 MULTIJET 16V

Non Runner

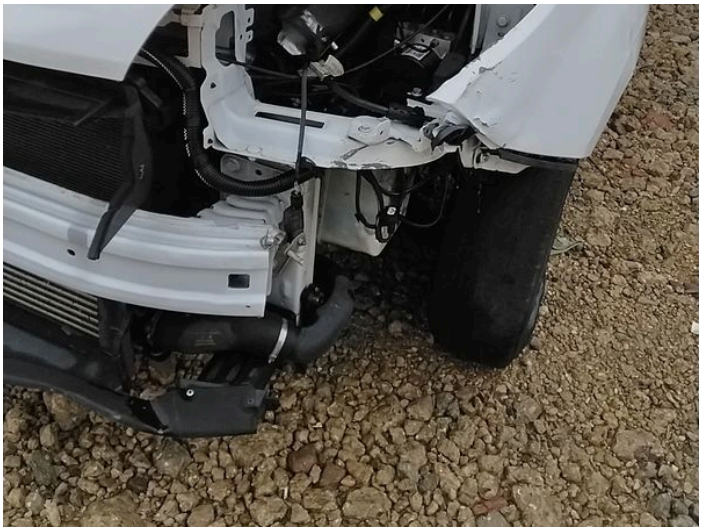
1: Wing osf
Scratched
UpTo 25mm Not Thru Paint

2: Bumper Front
Missing
Replace

3: Grille Front
Missing
Replace

4: Headlamp ns
Missing
Replace

5: Bonnet
Dented
Over 30mm

6: Wing nsf
Dented
With Paint Damage

7: Moulding nsf Wing
Missing
Replace

8: Door Mirror Assy nsf
Broken
Replace

9: Door nsf
Dented
With Paint Damage

10: B Post ns
Dented
With Paint Damage

11: Qtr Panel nsr
Dented
Over 30mm

12: Bumper Rear
Dented
Over 30mm

13: Tailgate
Hole
Over 10mm

14: Sill os
Dented
With Paint Damage

15: Door Mirror Assy osf
Scuffed (Unpainted)
UpTo 100mm

16: Door osf
Scratched
Over 25mm Not Thru Paint

17: Number Plate Front
Missing
Replace

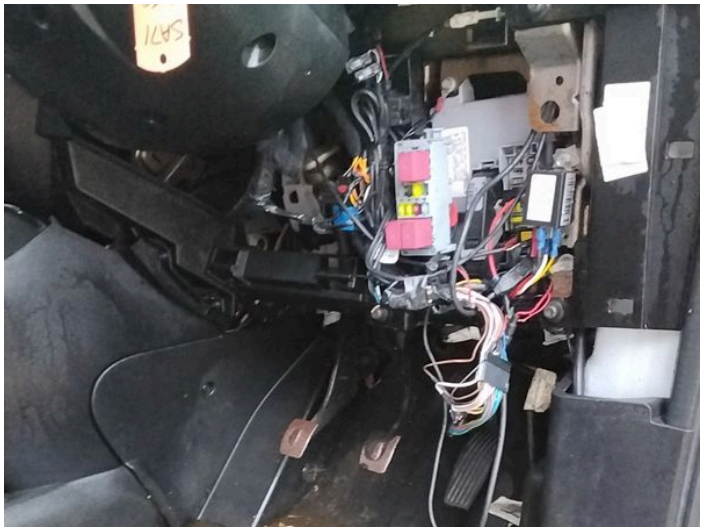
18: Seat Base Cover osf
Holed
Over 3mm

19: Seat Back Cover osf
Holed
Over 3mm

20: Fascia Trim
Damaged
Replace

21: Centre Console Front
Broken
Replace

22: Air Vents osf
Missing
Replace

23: Seat Belt nsf
Missing
Replace

24: Seat Belt osf
Missing
Replace
