VEHICLE INSPECTION REPORT

SA71KJE

Fiat Doblo 1.6 MULTIJET 16V

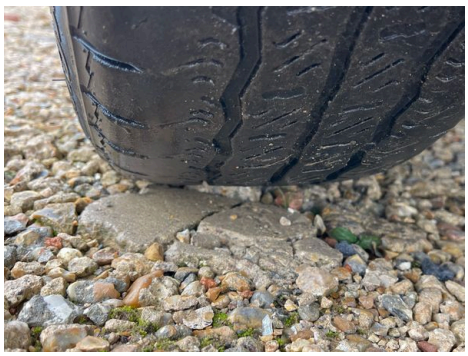
NON RUNNER-ENGINE & PARTS STRIPPED, DOES NOT POWER UP AD BLUE, MOT SHOWS 62,222 MILES 04/12/2024
