# VEHICLE INSPECTION REPORT

**YT68LFR**

## Ford Transit Custom 280 2.0 TDCI 105PS

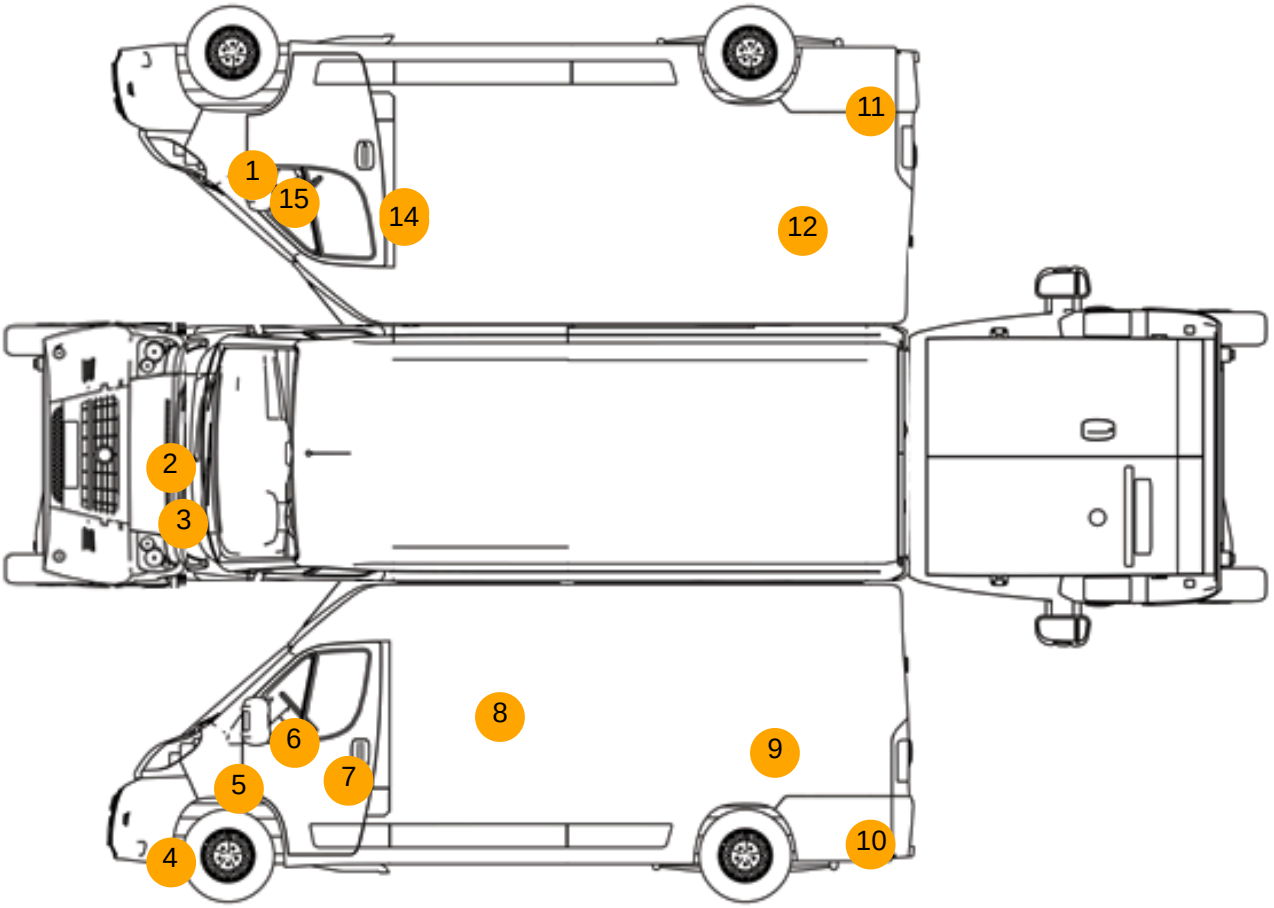
Speedometer
0 mph
97966.0 mls
