VEHICLE INSPECTION REPORT

ML20HDA

Citroen Dispatch 1000 1.5 BLUEHDI 100PS ENTERPRISE

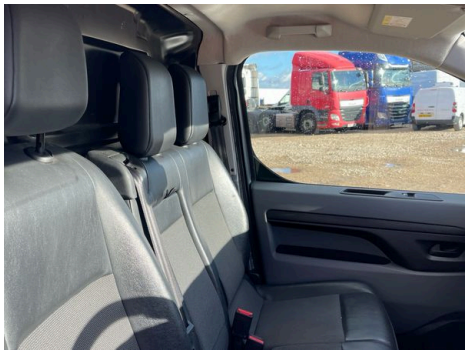
D/S SIDE DOOR NEEDS ATTN, NOT CONNECTED ON ROLLERS, WARNING LIGHTS ON DASH TWIN SIDE LOADING DOORS, E/MIRRORS
