VEHICLE INSPECTION REPORT

SC17RMX

Renault Master LL35 2.3 dCi 145PS Business Energy

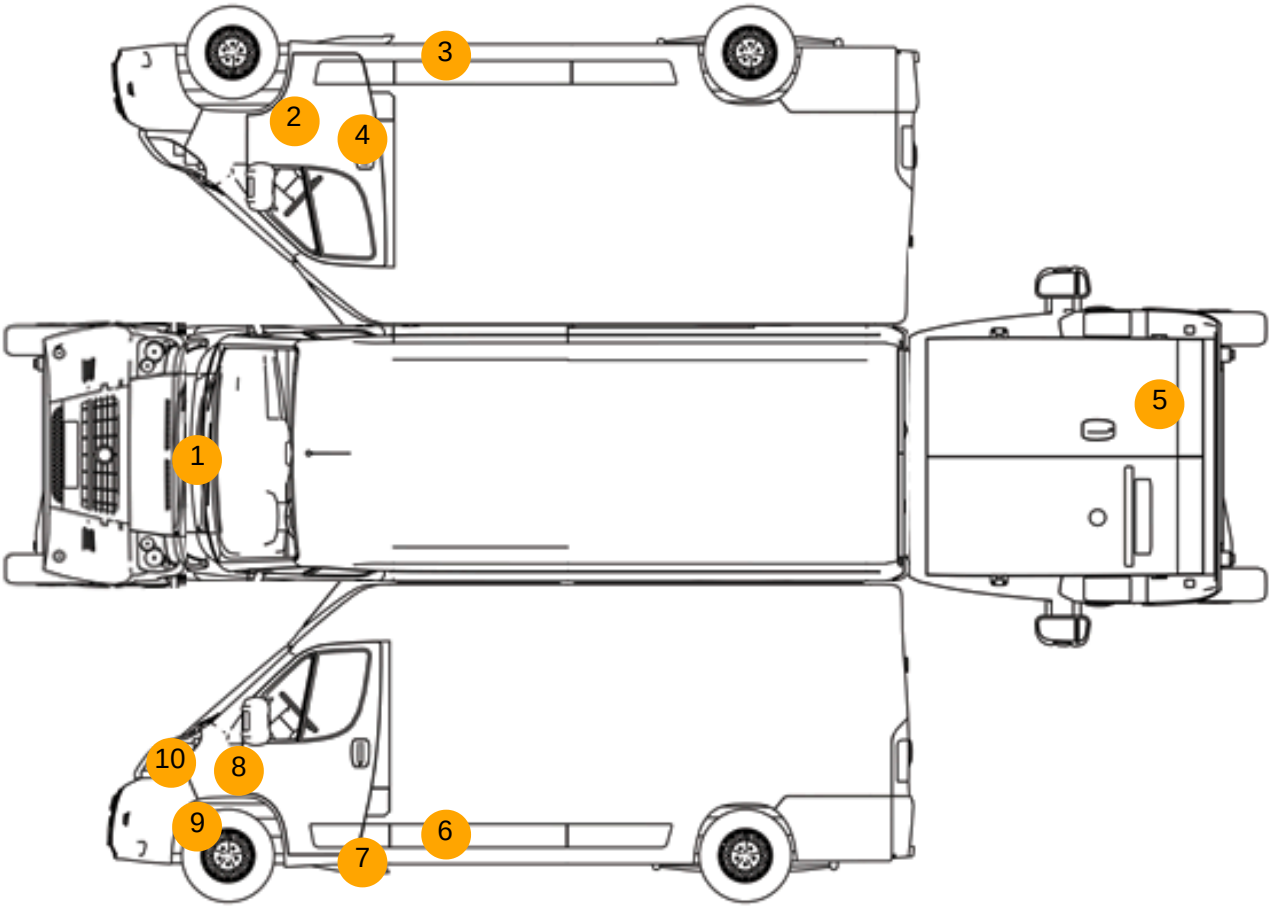
Damage Photos

1: Carpets Front
Holed
Over 3mm

2: Seat Back Cover osf
Torn
Over 3mm

3: Seat Base Cover nsf
Torn
Over 3mm

4: Bonnet
Chipped
Multiple Chips

5: Door osf
Rusted
Over 5mm

6: Sill os
Rusted
Over 5mm

7: Door osf
Chipped
Multiple Chips

8: Tailgate
Rusted
Over 5mm

9: Sill ns
Dented
With Paint Damage

10: Sill ns
Rusted
Over 5mm

11: Wing nsf
Dented
With Paint Damage

12: Bumper Front
Dented
With Paint Damage

13: Bumper Front Moulding
Broken
Replace
