VEHICLE INSPECTION REPORT

SC17RPY

Renault Master LL35 2.3 dCi 130PS Business

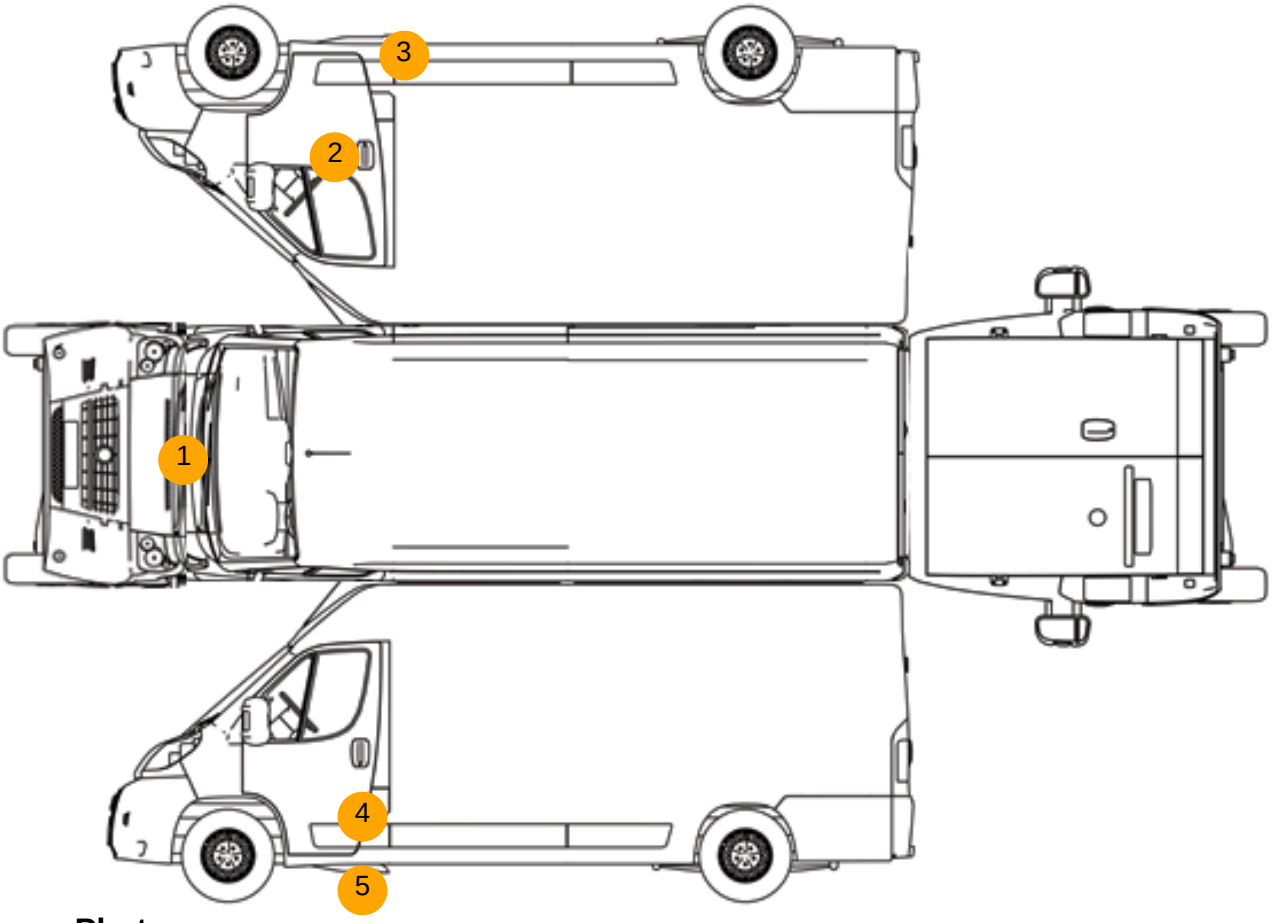
WARNING LIGHTS ON DASH TOW BAR, E/MIRRORS.

Engine Runs	OK	Gearbox 1st and Reverse Test	OK
Brakes	OK	Clutch Slip Test from Static	OK
Turbo Boosting	OK	Gearbox Static Gear Selection (engine running)	OK
Parking Brake	OK	No Excessive Smoking	OK
EML light illuminated	OK	Oil warning light illuminated	OK
Airbag light illuminated	OK	DPF light illuminated	OK
ABS light illuminated	Fault	Service indicator light illuminated	Fault
