VEHICLE INSPECTION REPORT

PX19RYM

Scania R 500

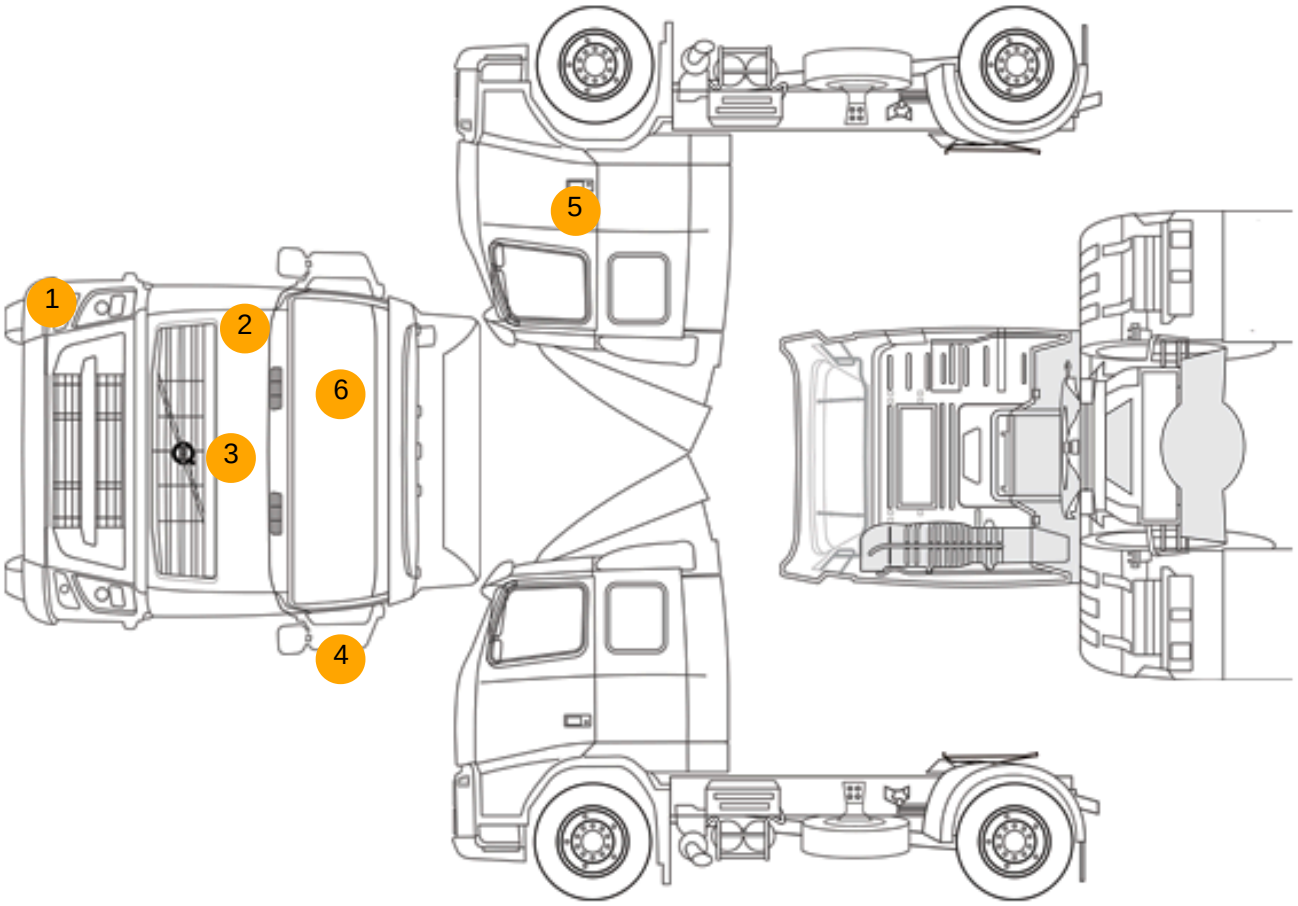
1: Bumper Front
Scratched
Over 100mm Thru Paint

2: Panel Front
Dented
With Paint Damage

3: Panel Front
Chipped
Multiple Chips

4: Door Mirror Assy nsf
Scuffed (Unpainted)
UpTo 100mm

5: Door osf
Chipped
Multiple Chips

6: Screen Front
Cracked
Replace

7: Seat Base Cover osf
Torn
Over 3mm
