VEHICLE INSPECTION REPORT

DU25VWH

Ford Transit 350 2.0 ECOBLUE 130PS LEADER

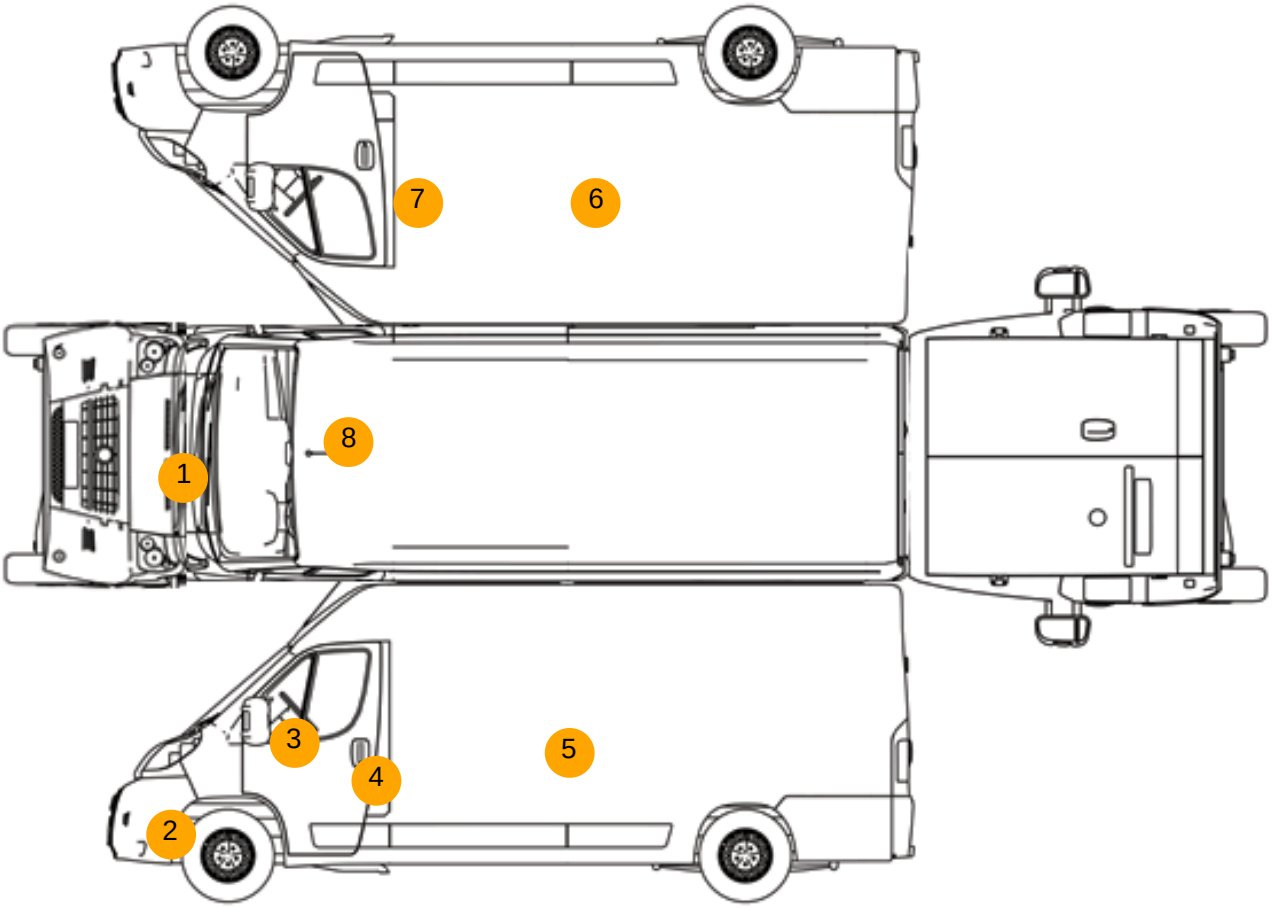
Condition Check

1: Bonnet
Chipped
Multiple Chips

2: Bumper Front Moulding
Scuffed (Unpainted)
UpTo 100mm

3: Door Mirror Assy nsf
Scuffed (Unpainted)
UpTo 100mm

4: Door nsf
Scratched
UpTo 25mm Not Thru Paint

5: Qtr Panel nsr
Scratched
Over 25mm Not Thru Paint

6: Qtr Panel osr
Scratched
Over 25mm Not Thru Paint

8: Roof
Rusted
Over 5mm
