VEHICLE INSPECTION REPORT

BU69TSX

Daf LF 230

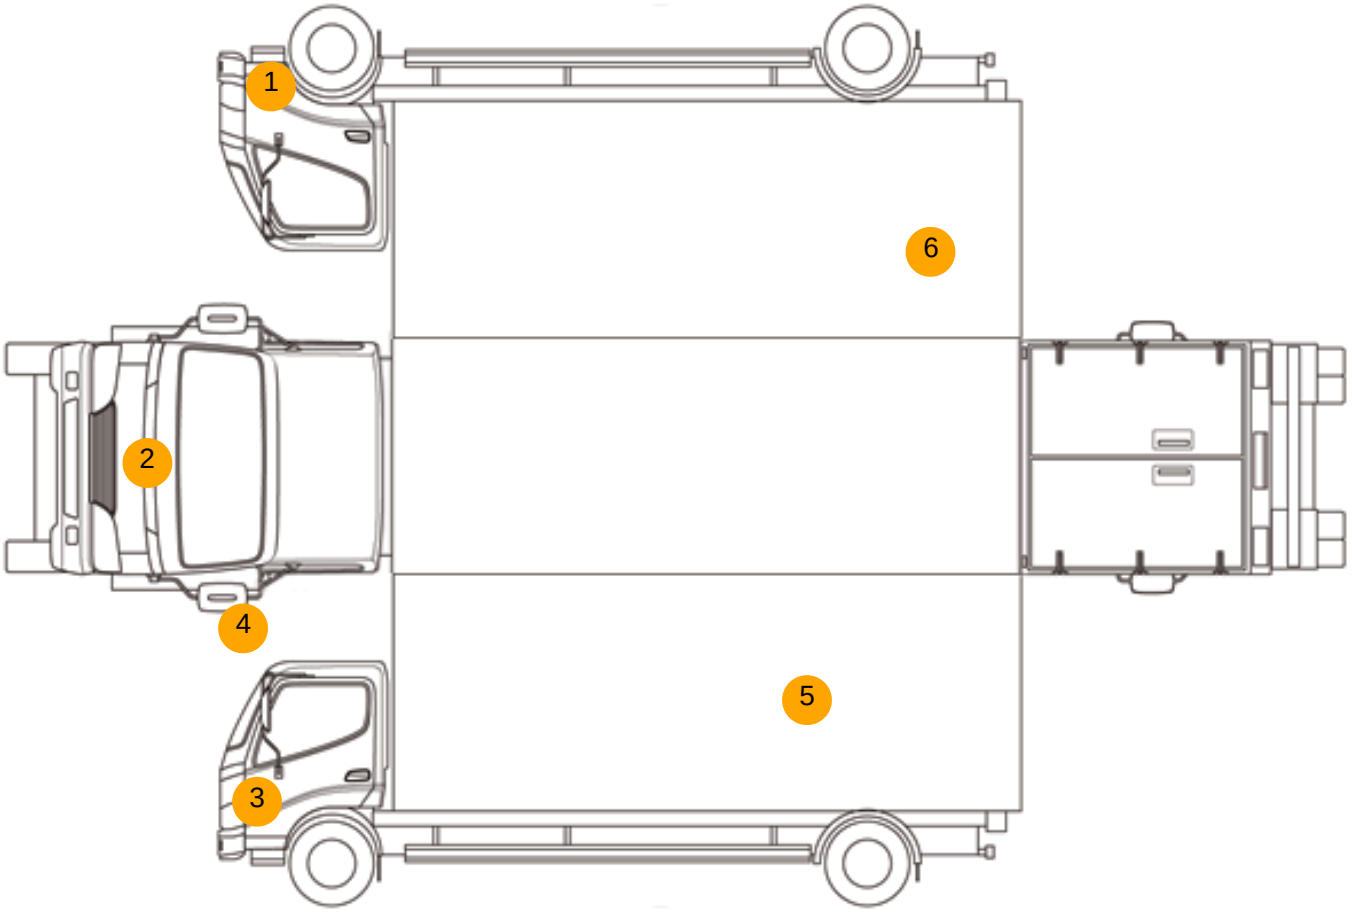
Condition Check

1: Bumper Front
Scratched
Over 100mm Thru Paint

2: Bonnet
Chipped
Multiple Chips

3: Panel Front
Scratched
Over 25mm Thru Paint

4: Door Mirror Assy nsf
Scuffed (Unpainted)
UpTo 100mm

5: Qtr Panel nsr
Scratched
Over 25mm Thru Paint

6: Qtr Panel osr
Cracked
Replace

7: Seat Base Cover osf
Torn
Over 3mm
