VEHICLE INSPECTION REPORT

KX19AXM

Isuzu D-Max 2.5TD

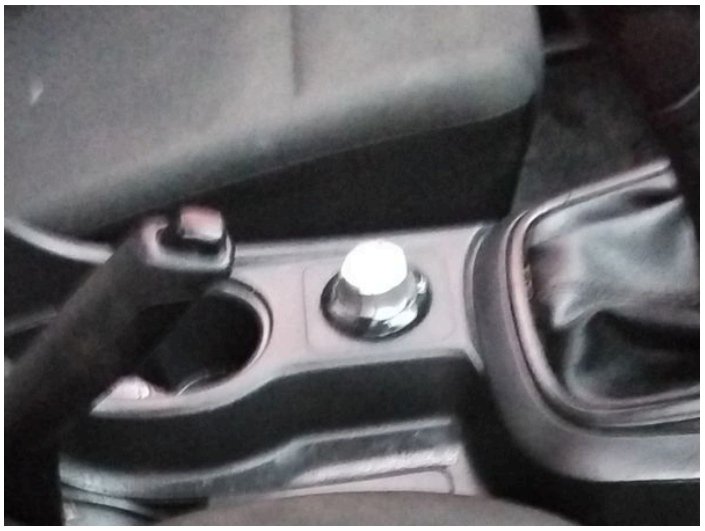
12: Seat Base Cover nsf
Soiled
Heavy
