VEHICLE INSPECTION REPORT

PE65UZV

DAF LF 220

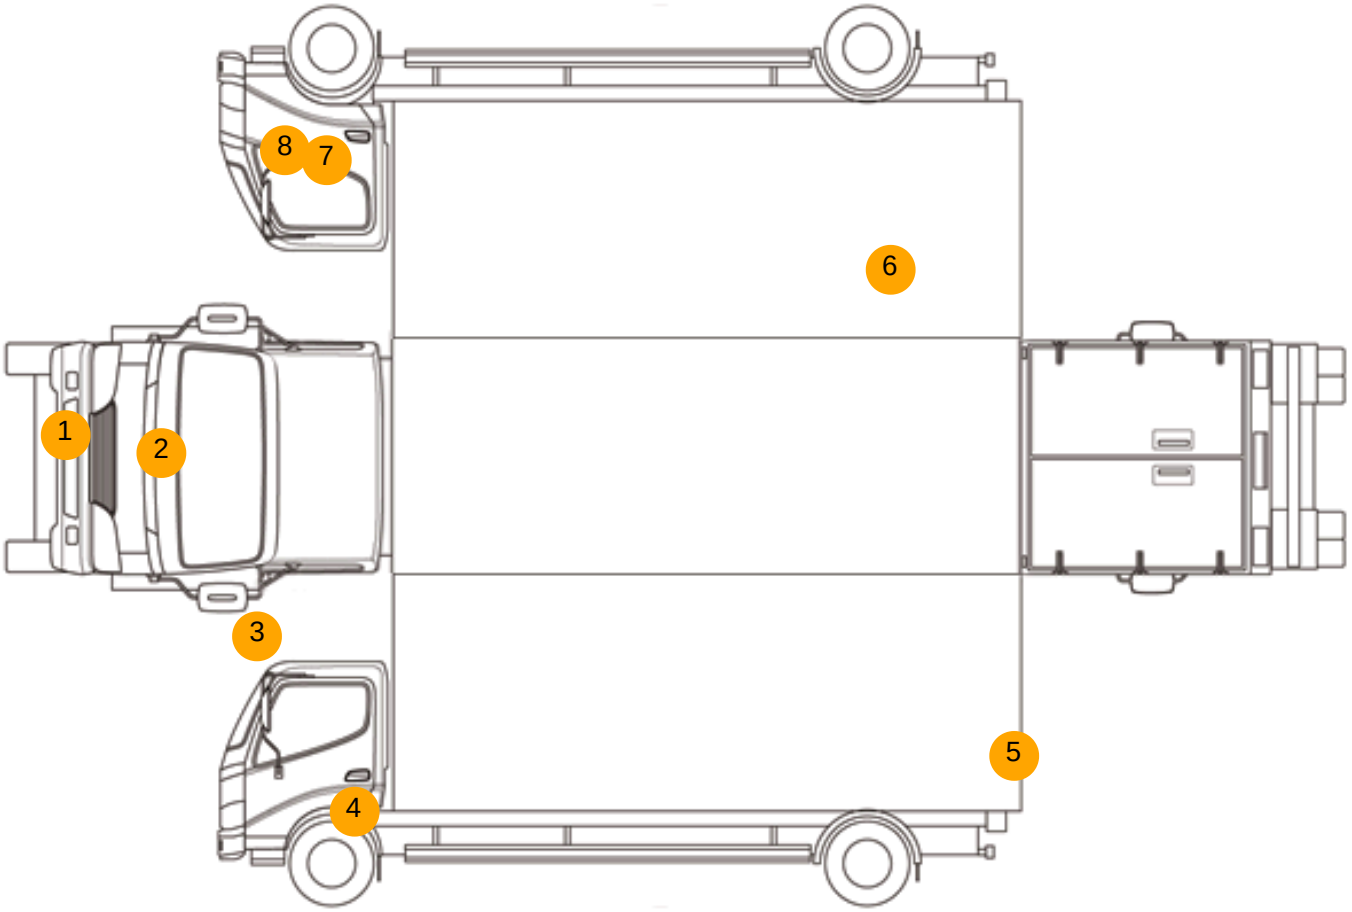
1: Bumper Front
Dented
With Paint Damage

2: Panel Front
Chipped
Multiple Chips

3: Door Mirror Assy nsf
Scuffed (Unpainted)
Over 100mm

4: Door nsf
Scratched
Over 25mm Thru Paint

5: Qtr Panel nsr
Dented
With Paint Damage

6: Qtr Panel osr
Scratched
Over 25mm Not Thru Paint

7: Door osf
Scratched
Over 25mm Thru Paint

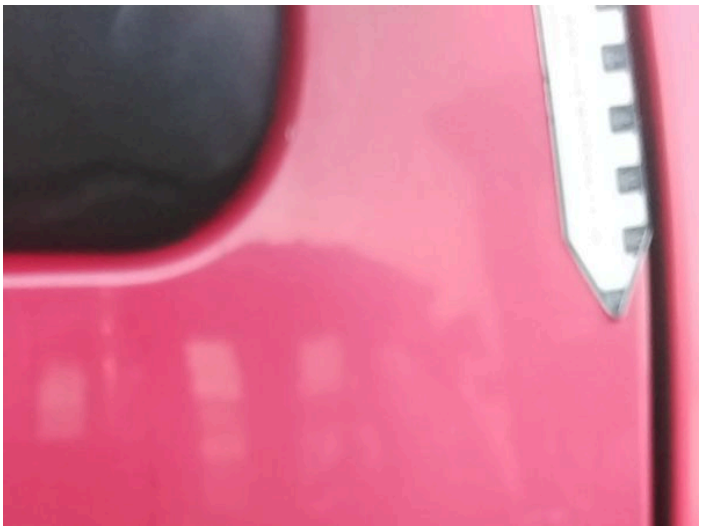
8: Door osf
Dented
With Paint Damage
