VEHICLE INSPECTION REPORT

T29SBL

Scania R 500

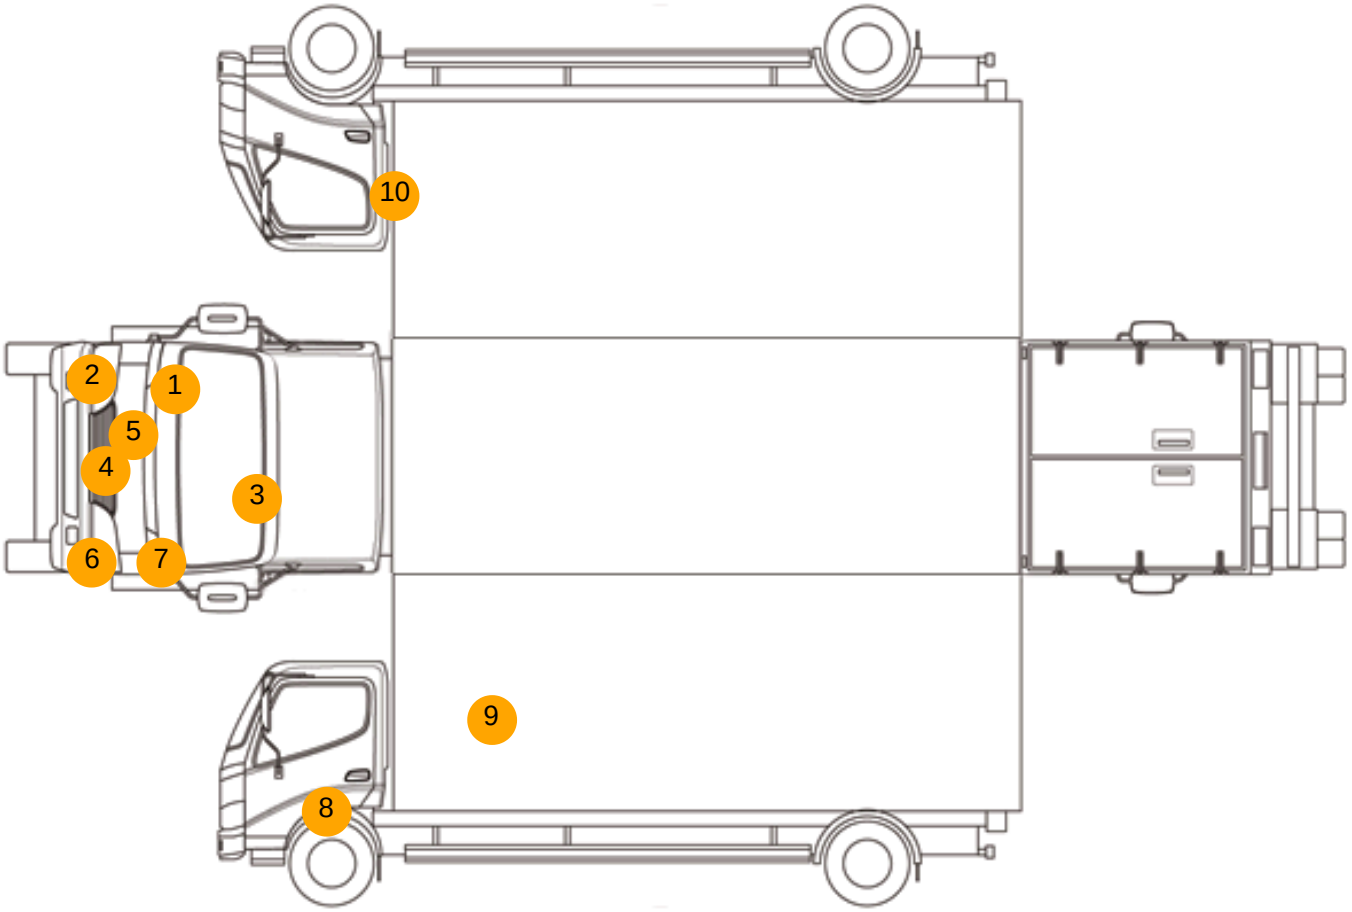
Damage Photos

1: Wing osf
Rusted
Over 5mm

2: Bumper Front
Scratched
25 to 100mm Thru Paint

3: Screen Front
Cracked
Replace

4: Bumper Front
Cracked
Over 25mm

5: Front TowEye Cvr
Missing
Replace

6: Bumper Front
Scratched
25 to 100mm Thru Paint

7: Wing nsf
Dented
With Paint Damage

8: Door nsf
Scratched
UpTo 25mm Not Thru Paint

9: Qtr Panel nsr
Scratched
Over 25mm Thru Paint

10: Door osf
Chipped
Edge Chip

11: Seat Base Cover osf
Holed
Over 3mm
