VEHICLE INSPECTION REPORT

FP69YWZ

Vauxhall Vivaro 2900 1.5D 100PS EDITION

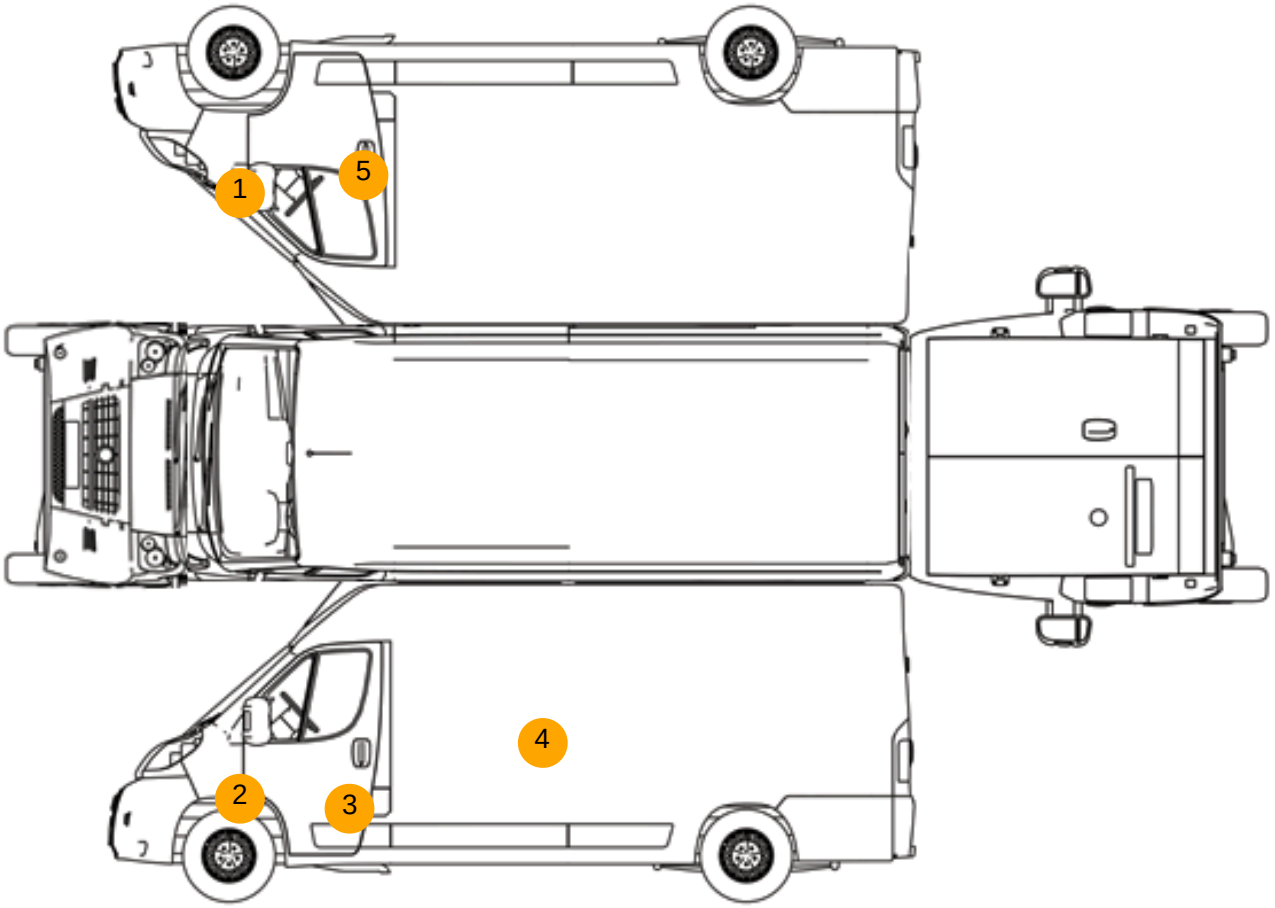
Condition Check

1: Wing osf
Scratched
Over 25mm Not Thru Paint

2: Wing nsf
Scratched
Over 25mm Thru Paint

3: Door nsf
Dented
With Paint Damage

4: Qtr Panel nsr
Dented
With Paint Damage

5: Door osf
Scratched
Over 25mm Thru Paint

6: Seat Base Cover osf
Holed
Over 3mm

7: Door Pad osf
Soiled
Heavy

8: Dash Warning Lights
Displayed
No Action

9: Seat Base Cover nsf
Scuffed
Over 25mm
