VEHICLE INSPECTION REPORT

YP22WVW

Ford Transit 350 2.0 ECOBLUE 130PS LEADER

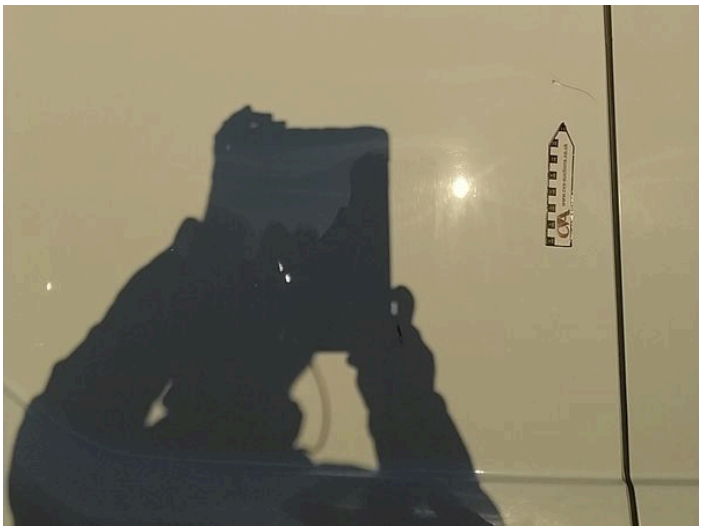
1: Door Mirror Assy nsf
Scuffed (Unpainted)
UpTo 100mm

2: Flasher Side Repeater ns
Broken
Replace

3: Door nsf
Scratched
Over 25mm Not Thru Paint

4: Qtr Panel Moulding ns
Broken
Replace

5: Door nsr
Scratched
Over 25mm Not Thru Paint

6: Qtr Panel nsr
Scratched
Over 25mm Thru Paint

7: Qtr Panel nsr
Dented
With Paint Damage

8: Door nsr
Dented
With Paint Damage

9: Door osr
Scratched
Over 25mm Thru Paint

10: Bumper Rear
Dented
Over 30mm

11: Qtr Panel osr
Dented
Over 30mm

12: Door Mirror Assy osf
Scuffed (Unpainted)
UpTo 100mm
