VEHICLE INSPECTION REPORT

HT23VYH

Ford Transit Base 350 2.0 EcoBlue 130ps LEADER

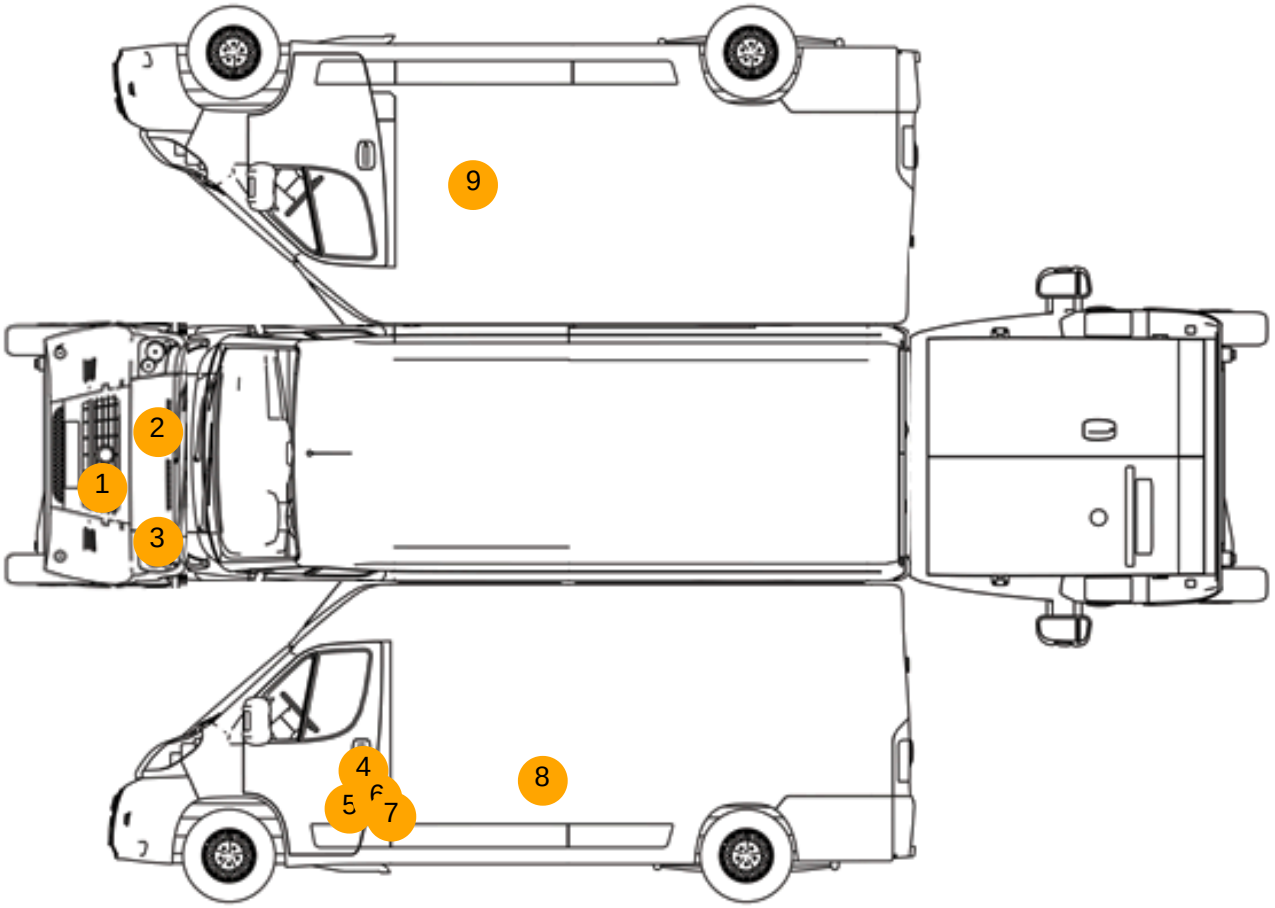
Condition Check

1: Number Plate Front
Broken
Replace

2: Panel Front
Scratched
Over 25mm Not Thru Paint

3: Panel Front
Scratched
Over 25mm Not Thru Paint

4: Door nsf
Dented
With Paint Damage

5: Door nsf
Scratched
Over 25mm Not Thru Paint

6: Door nsf
Dented
With Paint Damage

7: Fuel Flap
Cracked
Replace

8: Door nsr
Scratched
Over 25mm Thru Paint

9: Door osr
Scratched
Over 25mm Thru Paint

10: Seat Base Cover osr
Soiled
Heavy

11: Seat Base Cover nsr
Soiled
Heavy

12: Seat Back Cover osr
Soiled
Heavy

13: Seat Back Cover nsf
Soiled
Heavy

14: Seat Back Cover osf
Soiled
Heavy

15: Seat Base Cover nsf
Soiled
Heavy

16: Seat Base Cover nsf
Soiled
Heavy
