COMMERCIAL VEHICLE AUCTIONS LTD
THE UK'S MOST ESTABLISHED COMMERCIAL VEHICLE AUCTIONEERS

VEHICLE INSPECTION REPORT

DX20UKT

Daf XF 450

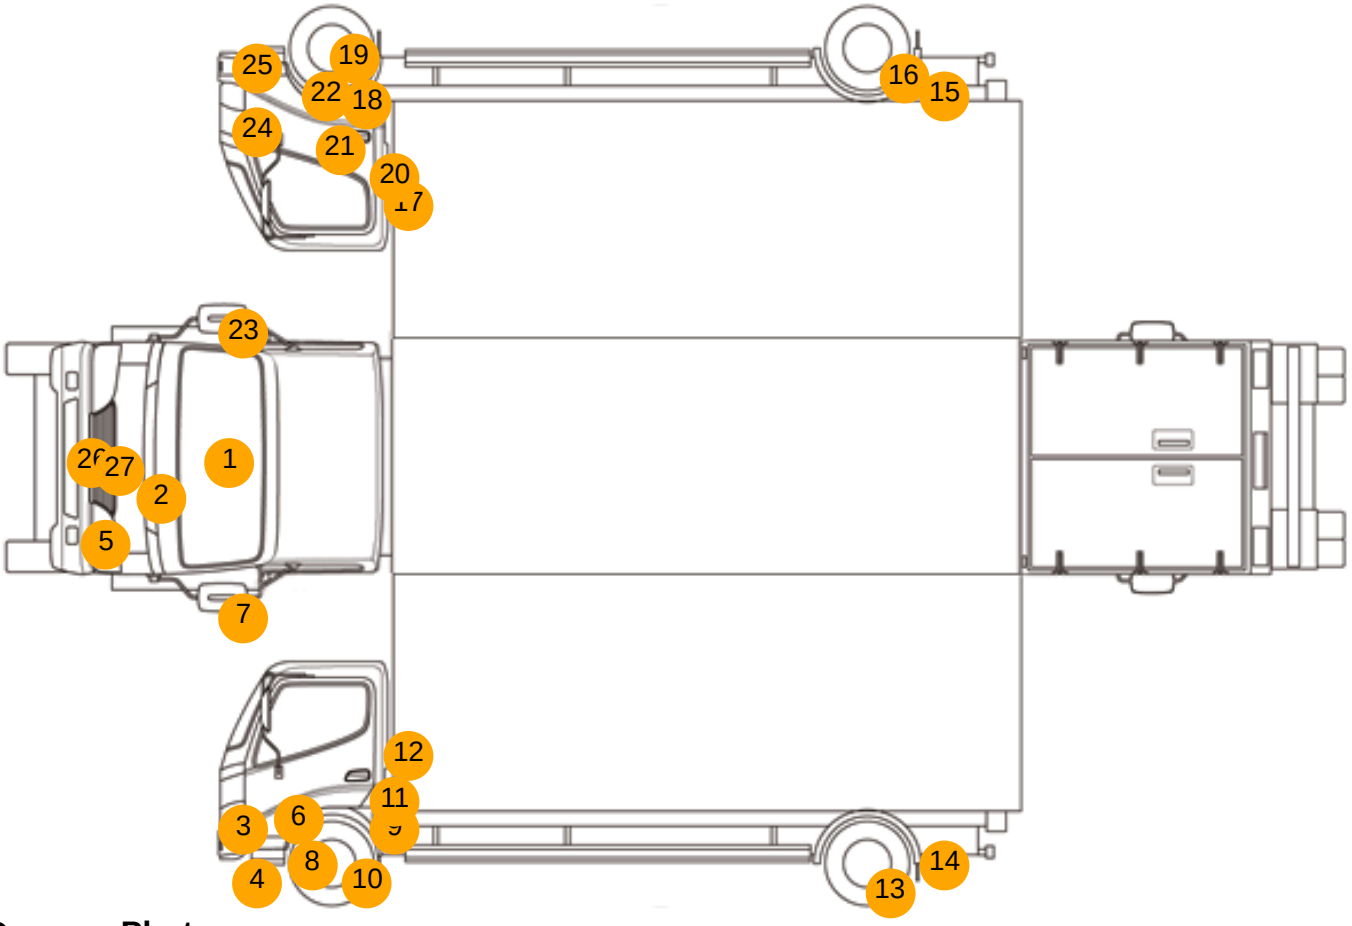
Condition Check

WARNING LIGHTS ON DASH

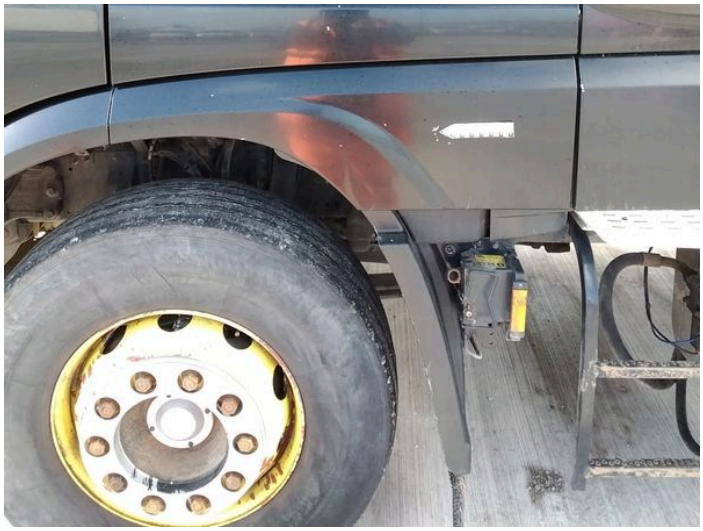
1: Screen Front
Chipped
Over 10mm

2: Panel Front
Chipped
Over 5mm

3: Wing nsf
Cracked
Replace

4: Bumper Front
Scratched
Over 100mm Thru Paint

5: Fog Lamp Surround ns
Scratched (Painted)
Over 25mm Thru Paint

6: Door nsf
Scratched
Over 25mm Thru Paint

7: Door Mirror Assy nsf
Scuffed (Unpainted)
Over 100mm

8: Wing Front Arch Extension ns
Scratched (Painted)
Over 25mm Thru Paint
