VEHICLE INSPECTION REPORT

ST70UEE

Ford Ranger Wildtrak 2.0 EcoBlue 213PS

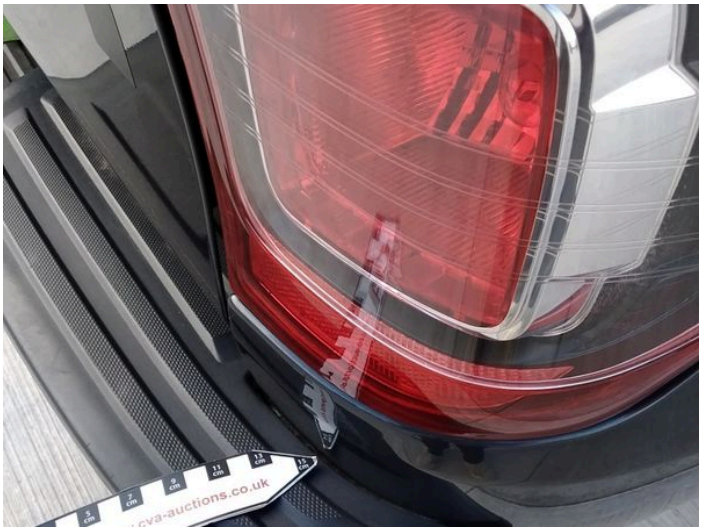
1: Bonnet
Chipped
Multiple Chips

2: Wing nsf
Scratched
Over 25mm Thru Paint

3: Wheel nsf
Scratched
Over 50mm

4: Wing nsf
Scratched
Over 25mm Thru Paint

5: Door Mirror Assy nsf
Broken
Replace

6: Door nsf
Scratched
Over 25mm Thru Paint

7: Door Mirror Glass ns
Broken
Replace

8: Qtr Panel Moulding ns
Missing
Replace

9: Door nsf
Scratched
Over 25mm Thru Paint

10: Qtr Panel nsr
Scratched
Over 25mm Thru Paint

11: Qtr Panel nsr
Scratched
Over 25mm Thru Paint

12: Qtr Panel nsr
Scratched
Over 25mm Thru Paint

13: Qtr Panel nsr
Scratched
Over 25mm Not Thru Paint

14: Wheel Trim nsr
Missing
Replace

15: Bumper Rear
Scratched
25 to 100mm Thru Paint

16: Bumper Rear
Dented
Over 30mm

17: Qtr Panel osr
Scratched
UpTo 25mm Thru Paint

18: Qtr Panel osr
Scratched
Over 25mm Thru Paint

19: Wheel osr
Scratched
Up To 50mm

20: Qtr Panel osr
Chipped
Multiple Chips

21: Door osf
Chipped
Multiple Chips

22: Bumper Front
Scratched
Over 100mm Thru Paint
