VEHICLE INSPECTION REPORT

HJ22OBU

Ford Transit 300 2.0 EcoBlue 130PS

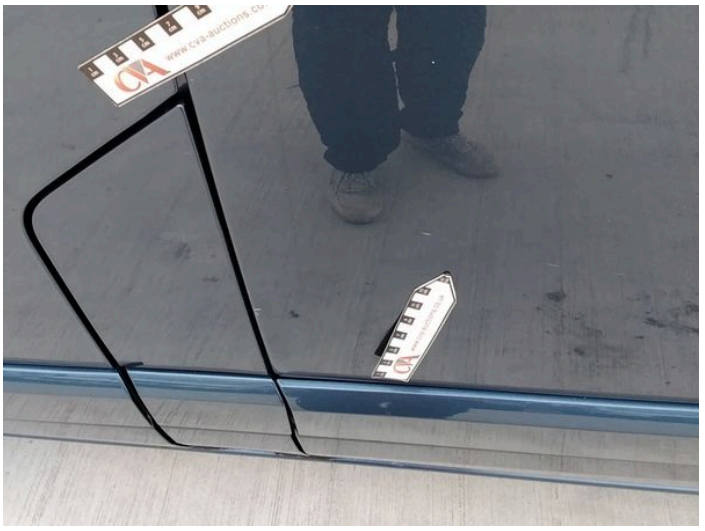
Damage Photos

1: Bonnet
Chipped
Multiple Chips

2: Grille Front
Scratched (Painted)
Over 25mm Thru Paint

3: Fog Lamp Surround ns
Broken
Replace

4: Bumper Front Moulding
Broken
Replace

5: Bumper Front
Scratched
25 to 100mm Thru Paint

6: Door Mirror Assy nsf
Scuffed (Unpainted)
Over 100mm

7: Door nsf
Scratched
Over 25mm Thru Paint

8: Qtr Panel nsr
Scratched
Over 25mm Thru Paint

9: Qtr Panel nsr
Scratched
UpTo 25mm Thru Paint

10: Qtr Panel nsr
Poor Previous Repair
Poor Paint

11: Qtr Panel Moulding ns
Scratched (Painted)
Over 25mm Thru Paint

12: Qtr Panel nsr
Scratched
Over 25mm Thru Paint

13: Qtr Panel nsr
Scratched
Over 25mm Thru Paint

14: Bumper Rear Moulding
Broken
Replace

15: Door osr
Scratched
Over 25mm Thru Paint

16: Door nsr
Dented
With Paint Damage

17: Door osr
Scratched
Over 25mm Thru Paint

18: Door nsr
Scratched
Over 25mm Thru Paint

19: Door osr
Scratched
Over 25mm Thru Paint

20: Bumper Rear
Scratched
25 to 100mm Thru Paint

21: Qtr Panel osr
Chipped
Multiple Chips

22: Qtr Panel osr
Scratched
Over 25mm Thru Paint

23: Qtr Panel Moulding ns
Scratched (Painted)
UpTo 25mm Thru Paint

24: Door osf
Chipped
Multiple Chips

25: Door osf
Scratched
Over 25mm Thru Paint

26: Door Mirror Assy osf
Scratched (Painted)
Over 25mm Thru Paint

27: Bumper Front
Chipped
Multiple Chips
