VEHICLE INSPECTION REPORT

AK73XND

Ford Transit 300 2.0 EcoBlue 130PS

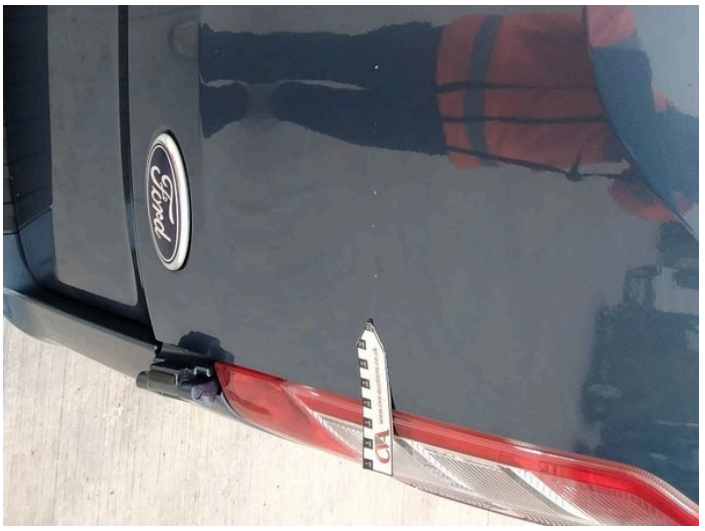
13: Qtr Panel nsr
Scratched
Over 25mm Thru Paint
