VEHICLE INSPECTION REPORT

HJ70XGK

Ford Ranger Wildtrak 2.0 EcoBlue 213PS

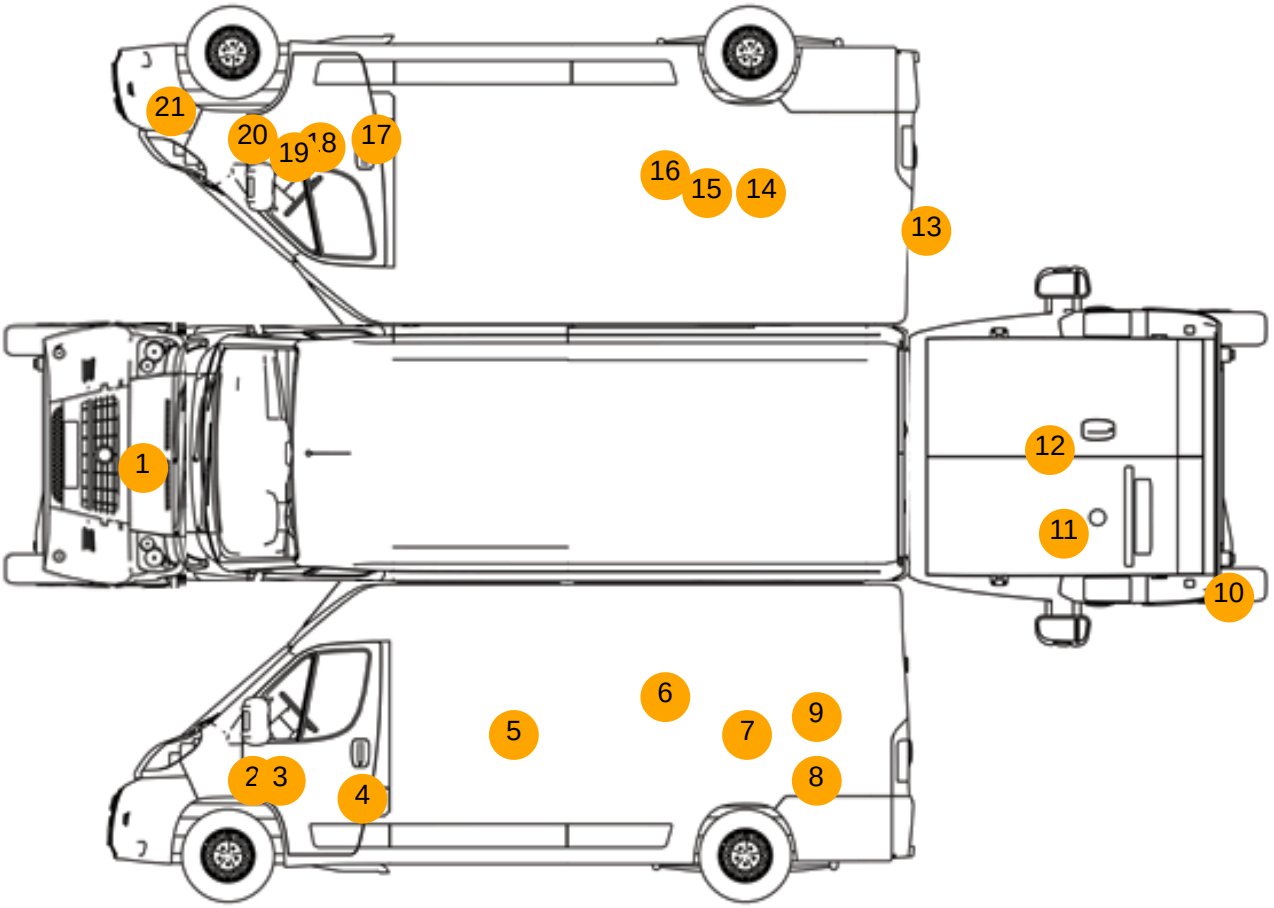
Condition Check

1: Bonnet
Chipped
Multiple Chips

2: Wing nsf
Dented
With Paint Damage

3: Wing nsf
Scratched
Over 25mm Thru Paint

4: Door nsf
Chipped
1 To 5

5: Qtr Panel nsr
Scratched
Over 25mm Thru Paint

6: Qtr Panel nsr
Dented
Between 10mm + 30mm

7: Qtr Panel nsr
Scratched
Over 25mm Thru Paint

8: Qtr Panel nsr
Scratched
Over 25mm Thru Paint

9: Qtr Panel nsr
Scratched
Over 25mm Thru Paint

10: Bumper Rear
Scratched
25 to 100mm Thru Paint

11: Tailgate
Scratched
Over 25mm Thru Paint

12: Tailgate
Scratched
Over 25mm Thru Paint

13: Qtr Panel osr
Chipped
1 To 5

14: Qtr Panel osr
Scratched
Over 25mm Not Thru Paint

15: Qtr Panel osr
Chipped
Multiple Chips

16: Qtr Panel osr
Scratched
Over 25mm Thru Paint

17: Door osf
Chipped
Multiple Chips

18: Door osf
Chipped
1 To 5

19: Wing osf
Scratched
Over 25mm Thru Paint

20: Wing osf
Scratched
Over 25mm Thru Paint

21: Bumper Front
Scratched
25 to 100mm Thru Paint
