VEHICLE INSPECTION REPORT

CE68EHV

Man TGX 26.460

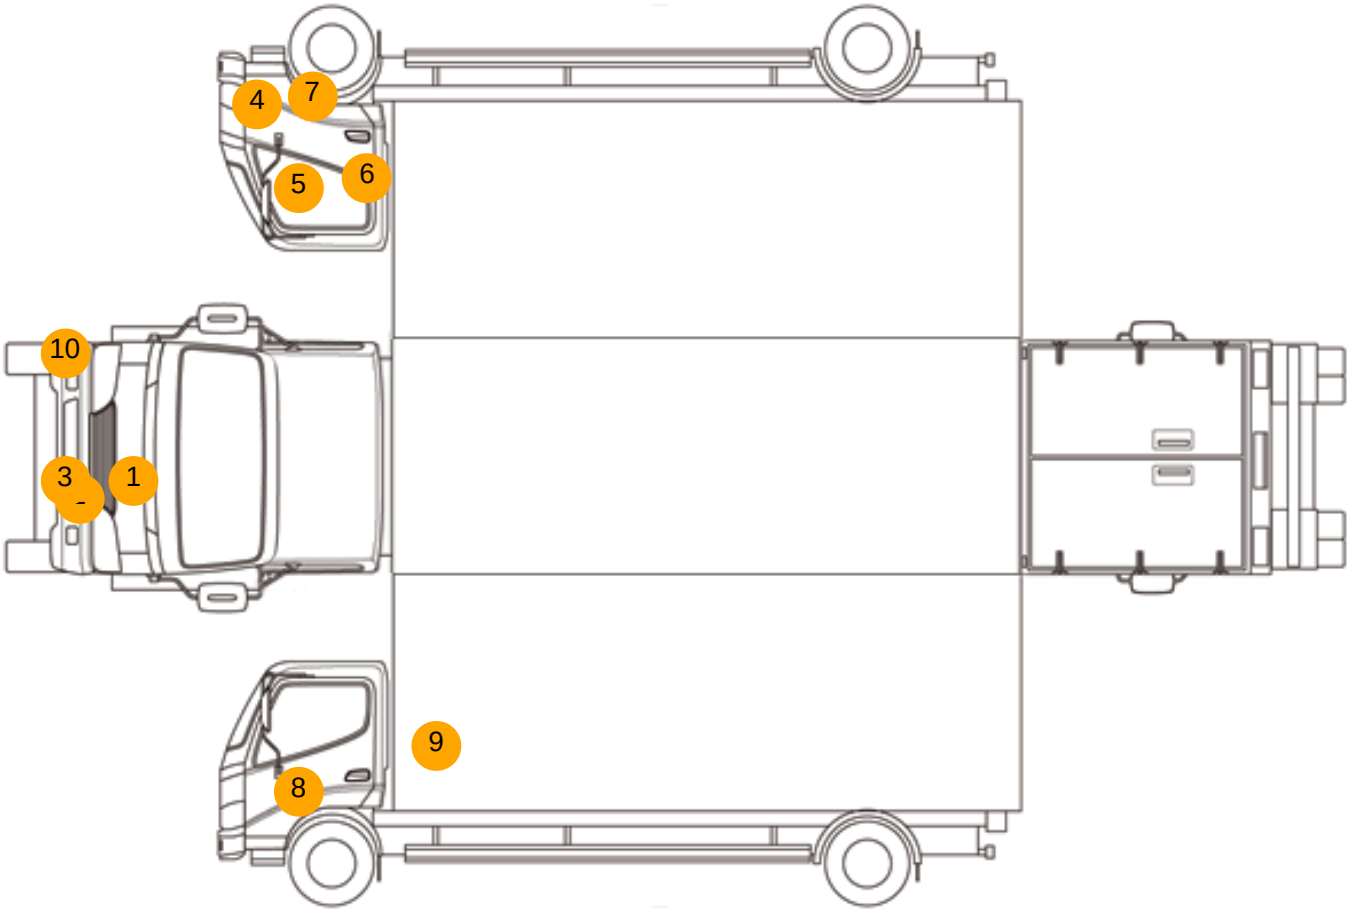
BEEN STANDING FOR OVER 12 MONTHS, WARNING LIGHTS ON DASH, SUSPENSION IS INOP OFF ROAD KIT ON FRONT, SLIDING 5TH WHEEL
