# VEHICLE INSPECTION REPORT

**PK67VFW**

## Daf CF 450

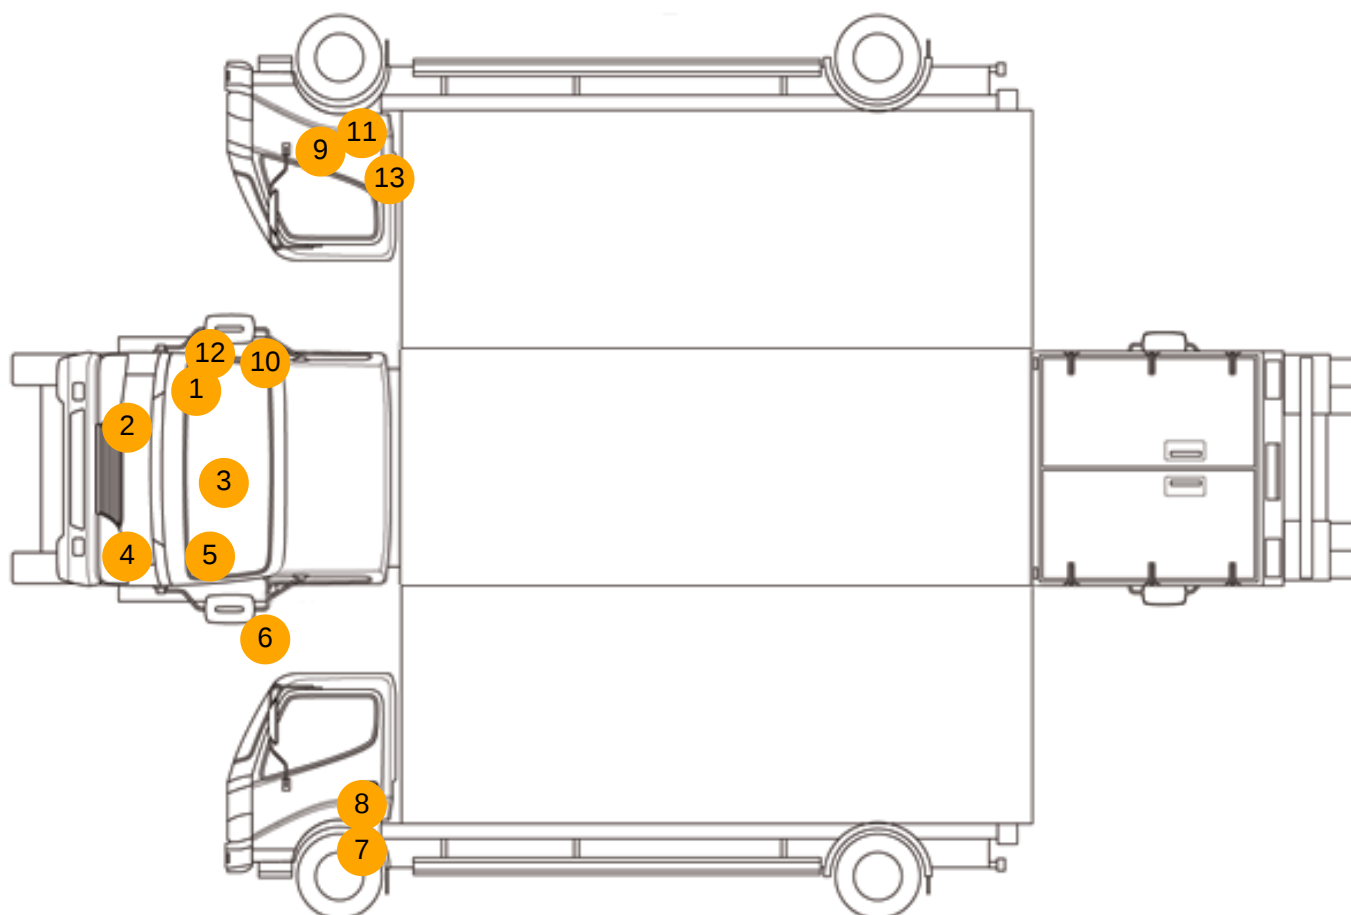
## Condition Check

1: Wing of  
Cracked  
Replace

9: Door osf  
Dented  
With Paint Damage

12: Door Mirror Assy osf  
Broken  
Replace

14: Switches And Controls  
Broken  
Replace
