## VEHICLE INSPECTION REPORT

**PJ73KUW**

### Volkswagen Crafter CR35 2.0 TDI 140PS

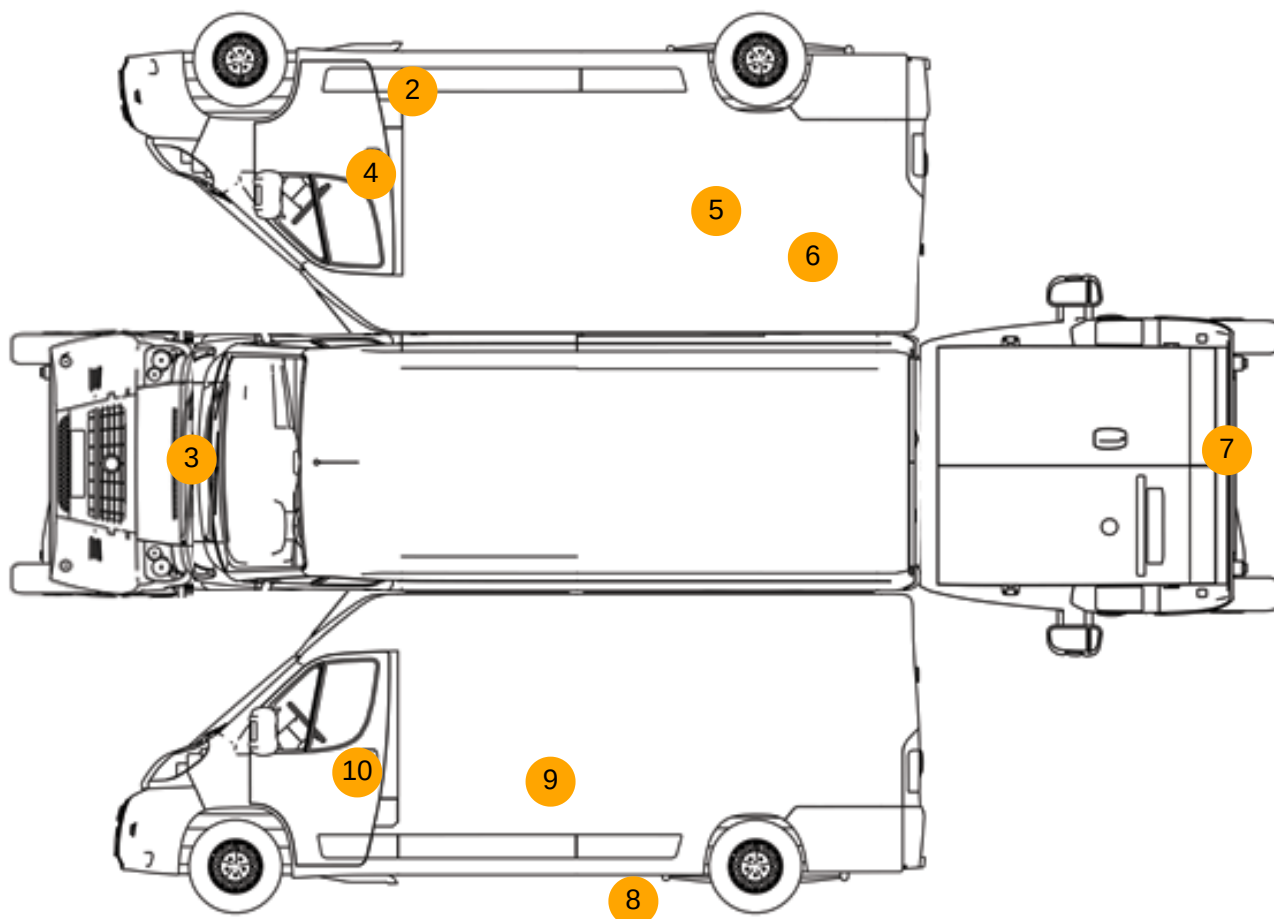
## Condition Check

5: Qtr Panel Moulding os  
Broken  
Replace

6: Qtr Panel osr  
Dented  
With Paint Damage

7: Bumper Rear Moulding  
Broken  
Replace

8: Sill ns  
Dented  
With Paint Damage
