**COMMERCIAL VEHICLE AUCTIONS LTD**  
THE UK'S MOST ESTABLISHED COMMERCIAL VEHICLE AUCTIONEERS

# VEHICLE INSPECTION REPORT

**BX13LWO**

## Mitsubishi L200

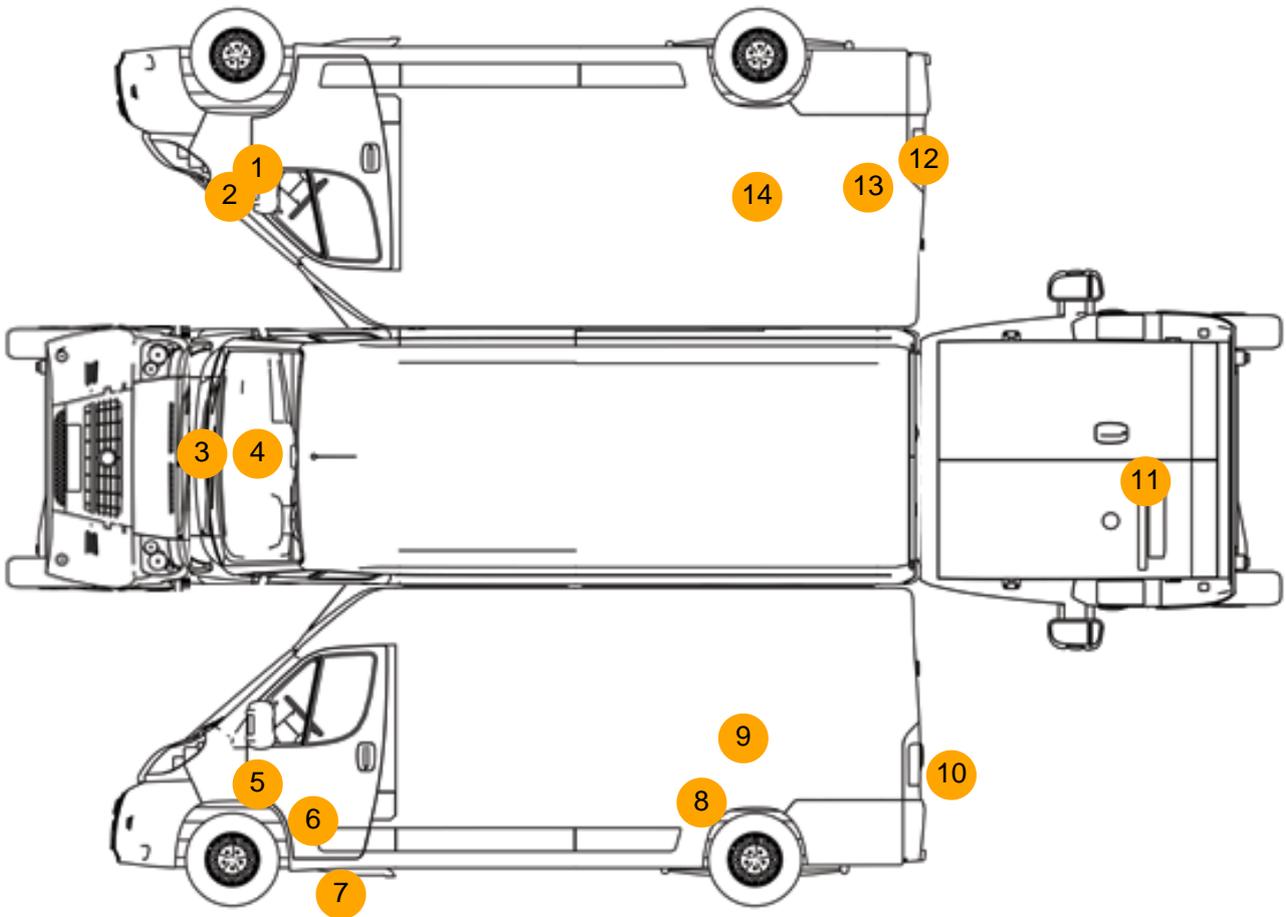
## Condition Check

1: Wing osf  
Dented  
Over 30mm

5: Wing nsf  
Dented  
With Paint Damage

7: Sill ns  
Dented  
With Paint Damage

10: Qtr Panel nsr  
Dented  
With Paint Damage

11: Panel Rear  
Rusted  
Over 5mm

14: Qtr Panel osr  
Rusted  
Over 5mm
