# VEHICLE INSPECTION REPORT

**WN14VGZ**

## Fiat Doblo 1.3 Multijet 16V

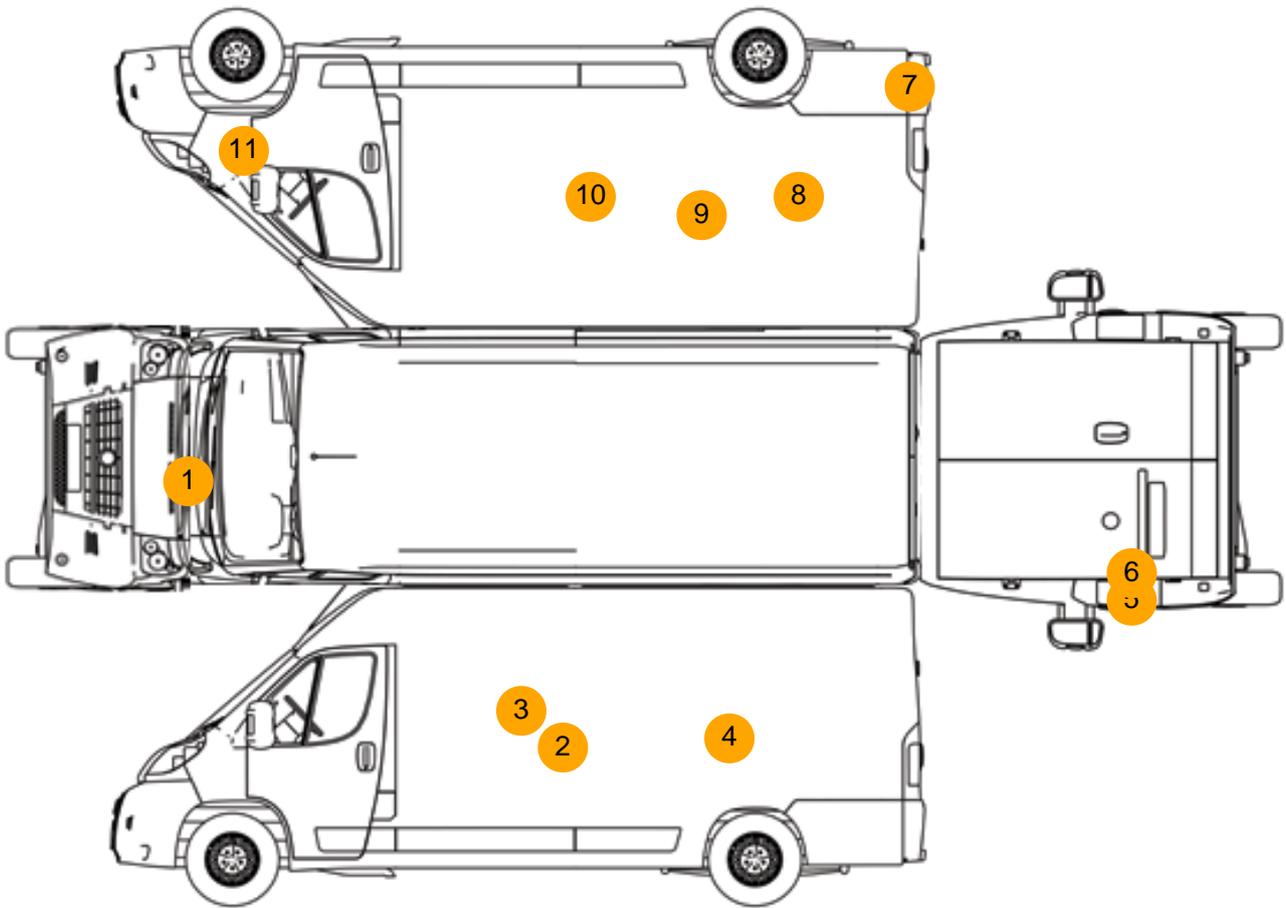
## Condition Check

1: Bonnet  
Chipped  
Multiple Chips

2: Qtr Panel nsr  
Dented  
With Paint Damage

3: Qtr Panel nsr  
Scratched  
Over 25mm Thru Paint

5: Lamp nsr  
Broken  
Replace

6: Door nsr  
Dented  
With Paint Damage

13: Fascia Panel  
Missing  
Replace
