VEHICLE INSPECTION REPORT

DG68MWX

Isuzu D-Max 1.9

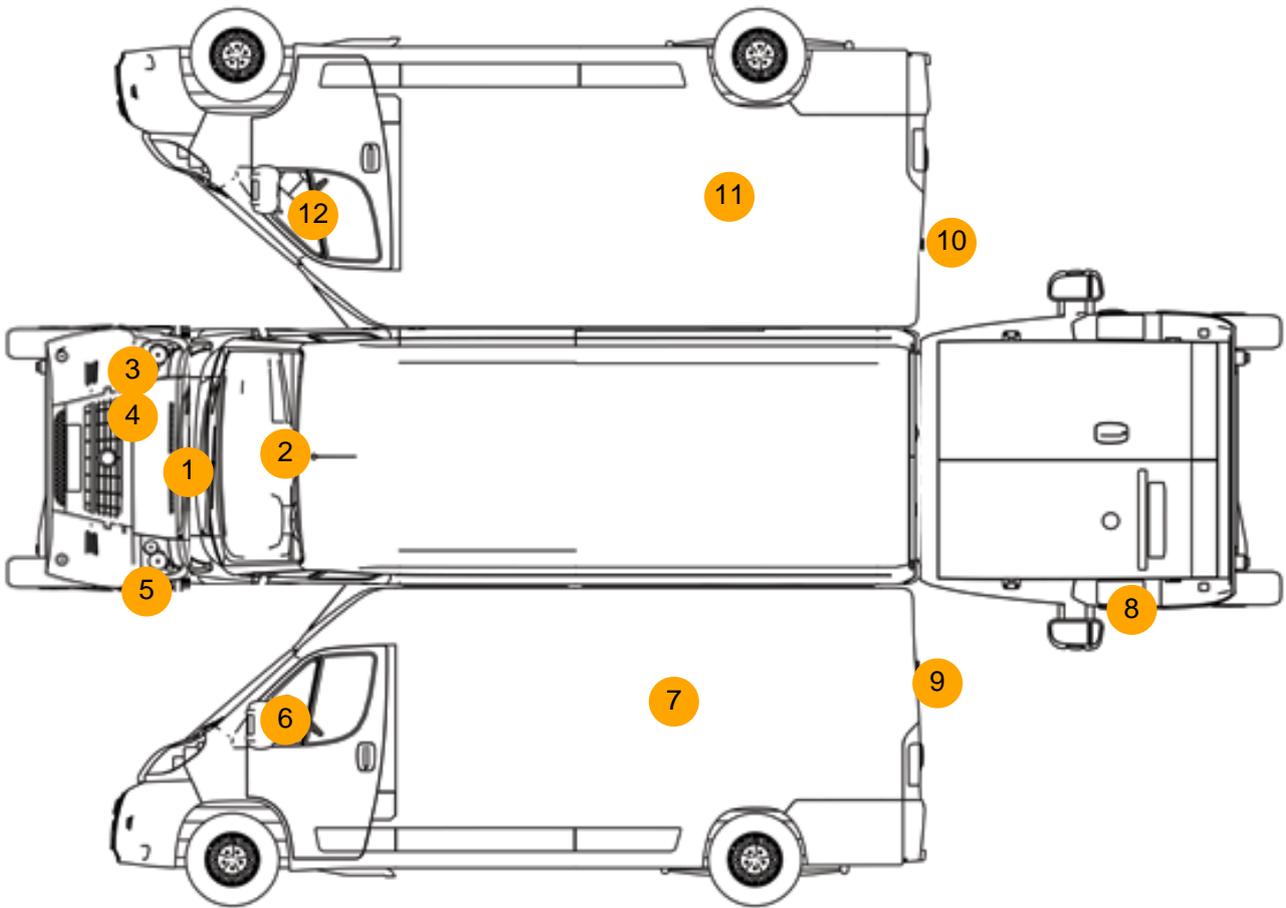
Condition Check

3: Bumper Front Moulding
Broken
Replace

7: Qtr Panel nsr
Cracked
Replace

8: Lamp nsr
Broken
Replace

10: Qtr Panel osr
Cracked
Replace

11: Qtr Panel osr
Cracked
Replace
