VEHICLE INSPECTION REPORT

DF13URP

Mercedes-Benz Actros 1842

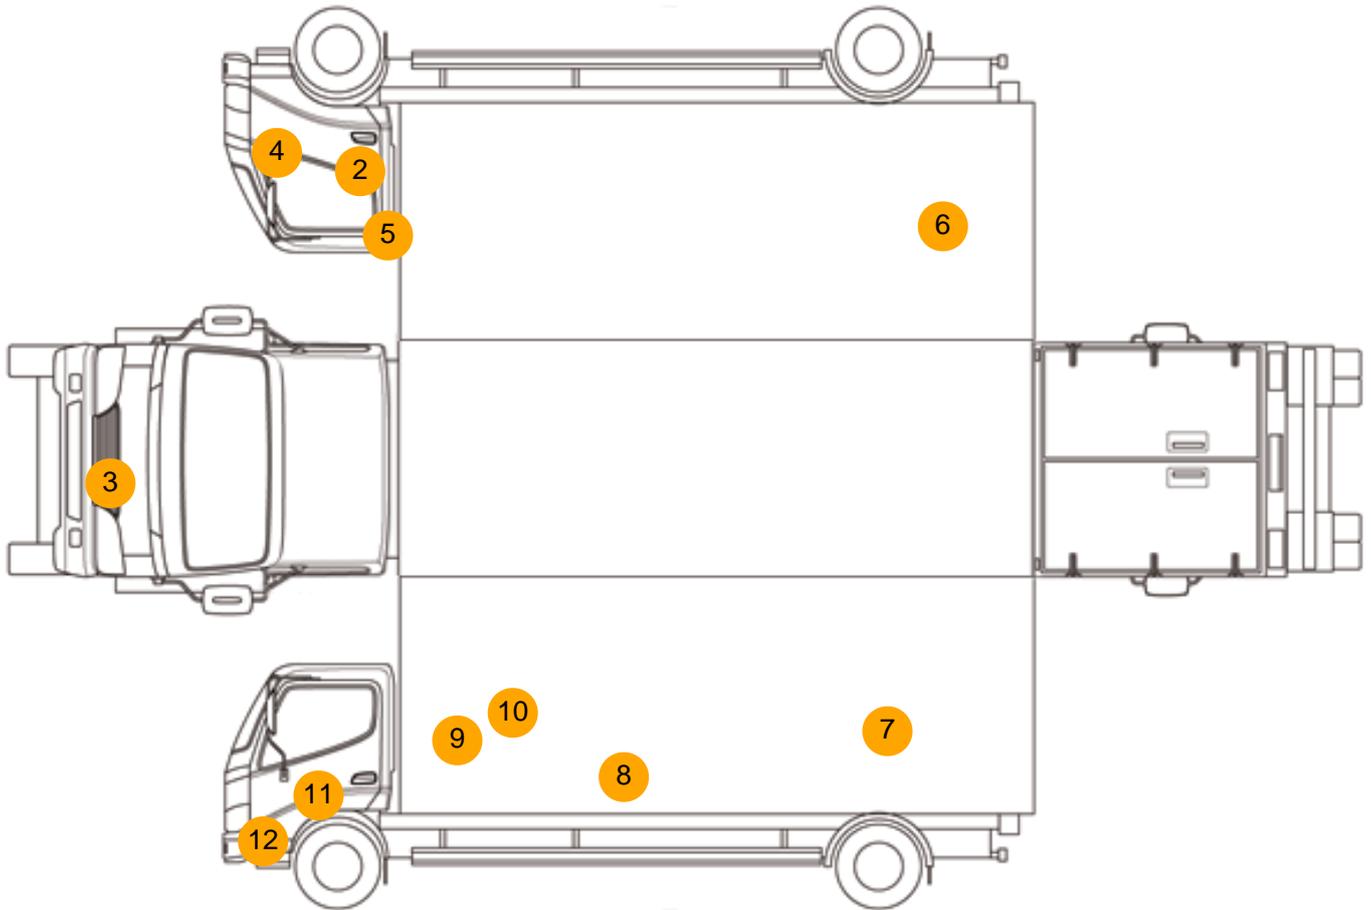
Condition Check

Carpet Condition	Average	Upholstery Condition	Average
Seat Condition	Average	Odour	-
Engine Runs	OK	Gearbox 1st and Reverse Test	OK
Brakes	OK	Clutch Slip Test from Static	OK
Turbo Boosting	OK	Gearbox Static Gear Selection (engine running)	OK
Parking Brake	OK	No Excessive Smoking	OK
EML light illuminated	OK	Oil warning light illuminated	OK
Airbag light illuminated	OK	DPF light illuminated	OK
ABS light illuminated	OK	Service indicator light illuminated	OK
