VEHICLE INSPECTION REPORT

PO13ECJ

Daf LF 45.140

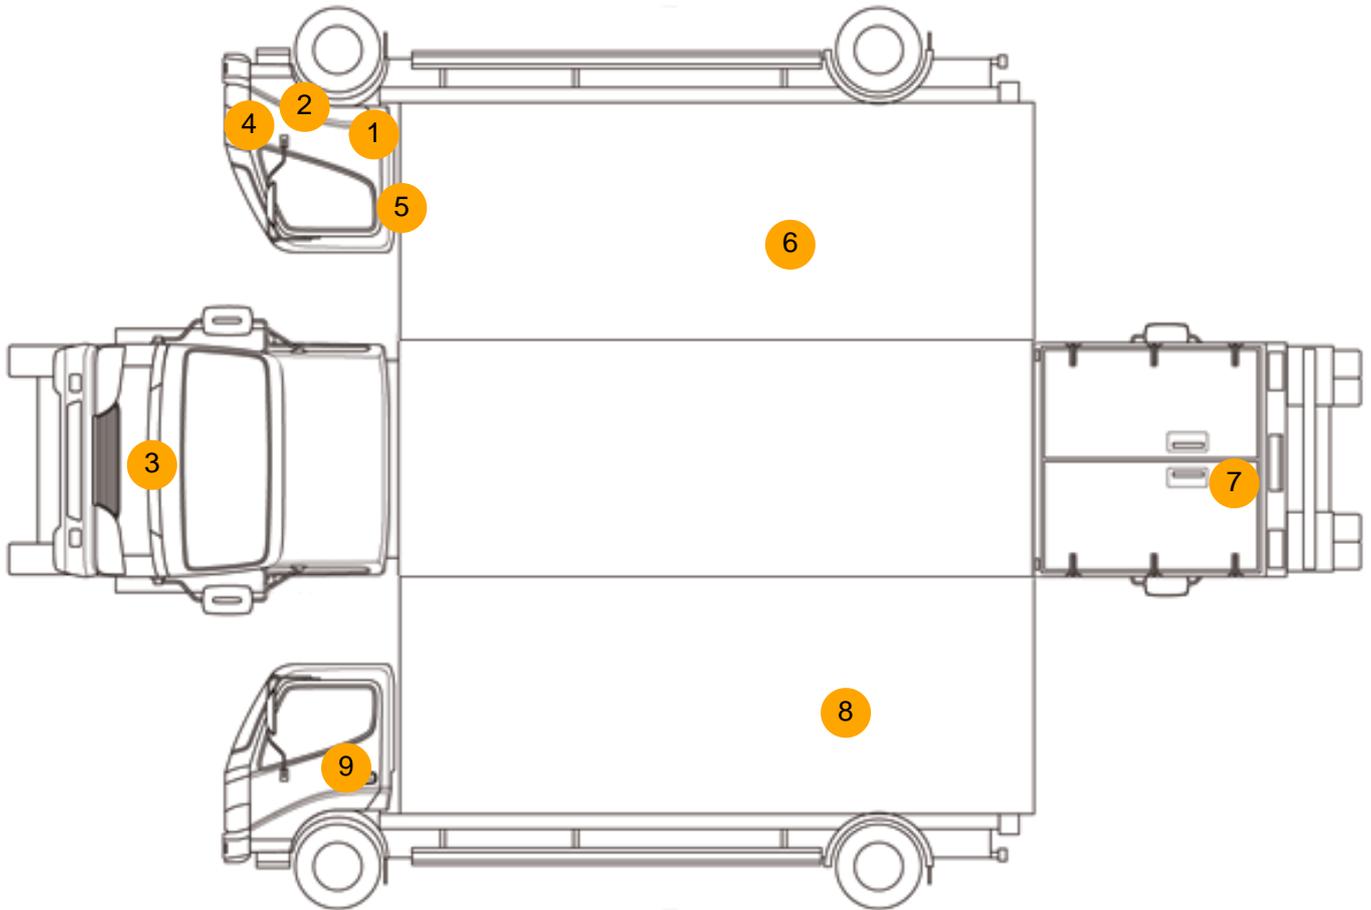
Condition Check

COLLECTED AS NON-RUNNER, CAB CORROSION, TAIL LIFT PLATFORMS, FAULTS NEED ATTENDTION, WARNING LIGHTS ON DASH
