COMMERCIAL VEHICLE AUCTIONS LTD
THE UK'S MOST ESTABLISHED COMMERCIAL VEHICLE AUCTIONEERS

VEHICLE INSPECTION REPORT

PJ70KRZ

Mercedes-Benz Sprinter 314 CDI

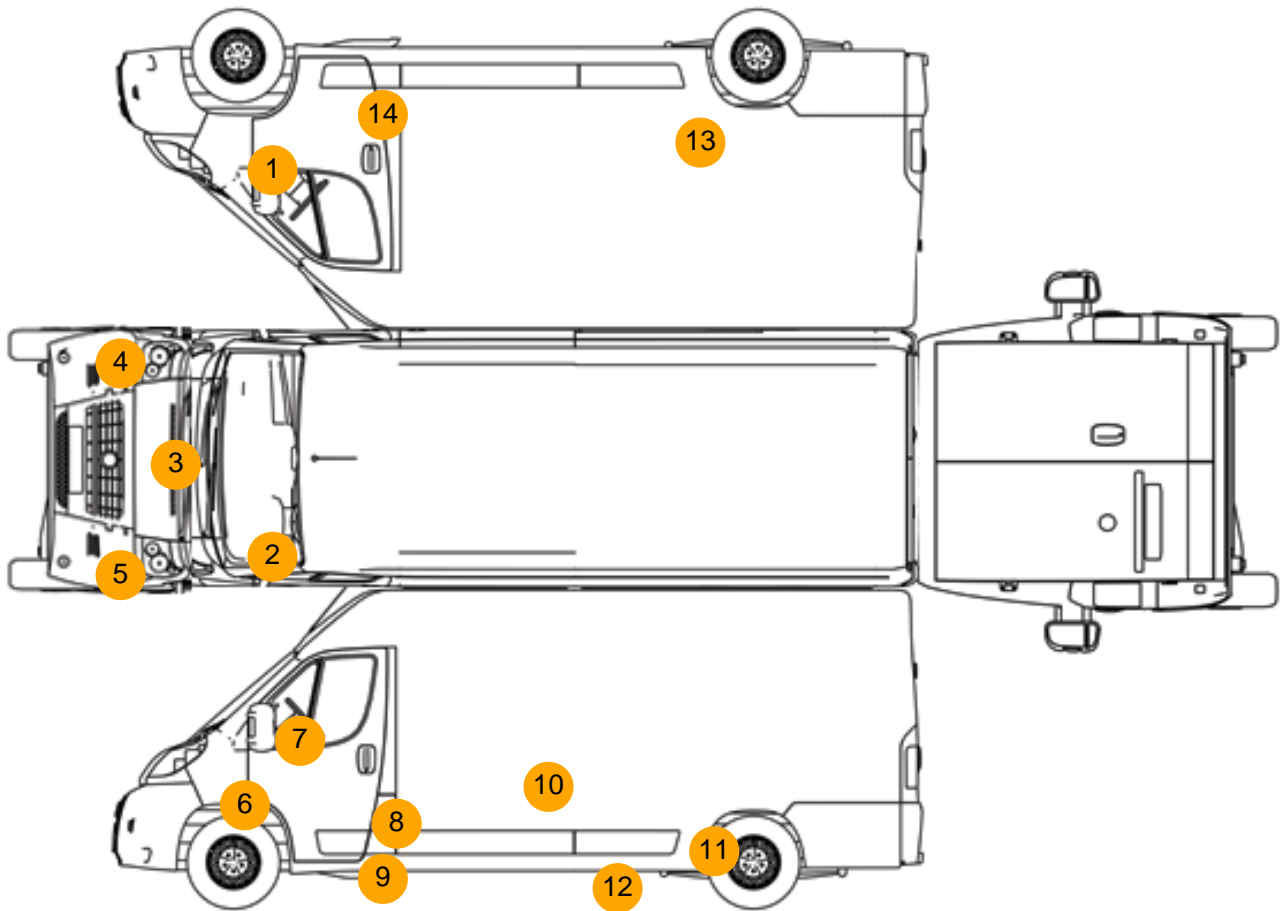
Condition Check

1: Wing osf
Dented
With Paint Damage

6: Wing nsf
Dented
With Paint Damage

8: B Post ns
Dented
With Paint Damage

9: Sill ns
Dented
With Paint Damage

12: Sill ns
Dented
With Paint Damage

14: Door osf
Dented
With Paint Damage
