VEHICLE INSPECTION REPORT

WX17UTC

Isuzu D-Max 2.5TD

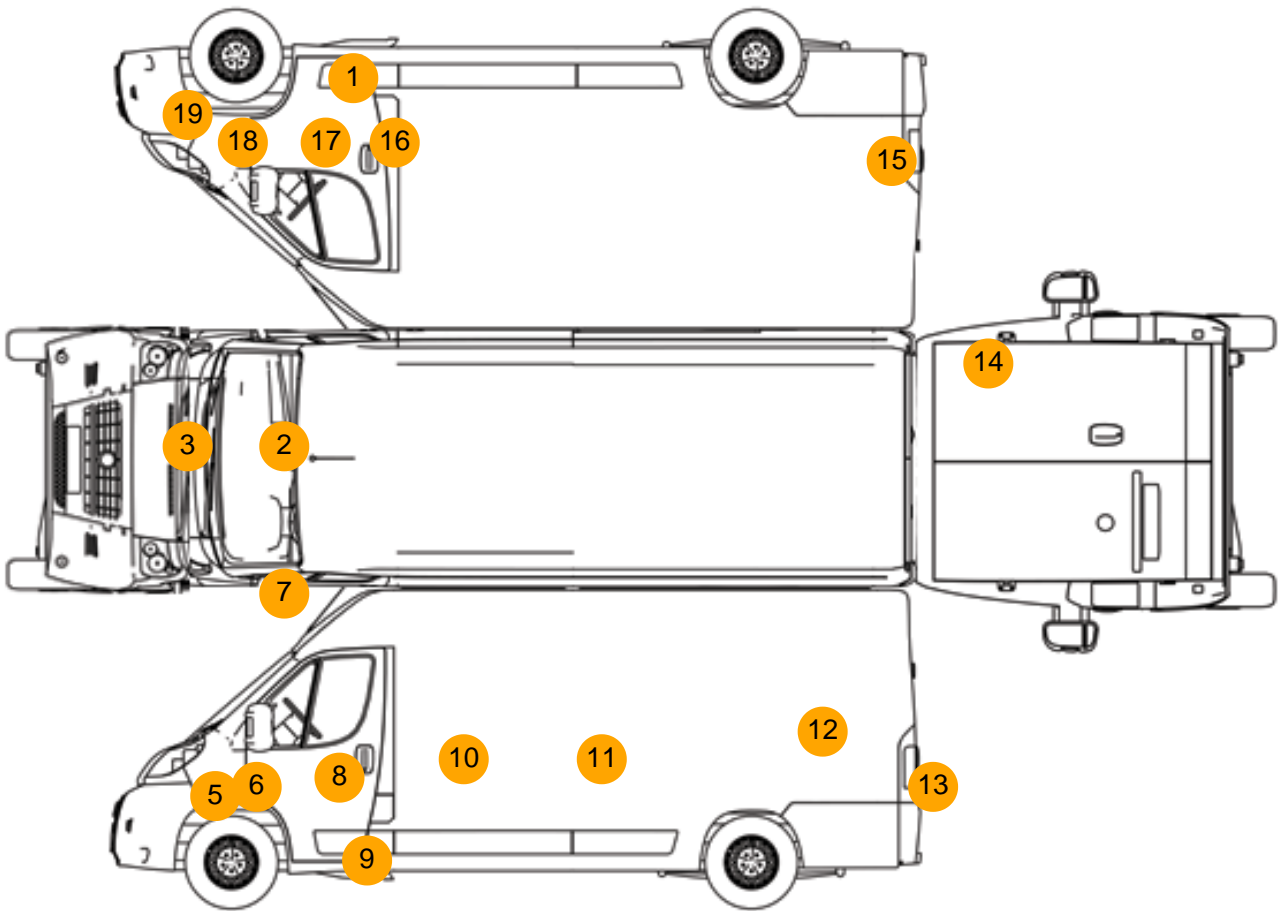
Condition Check

Carpet Condition	Average	Upholstery Condition	Average
Seat Condition	Average	Odour	-
Engine Runs	OK	Gearbox 1st and Reverse Test	OK
Brakes	OK	Gearbox Static Gear Selection (engine running)	OK
Parking Brake	OK	No Excessive Smoking	Fault
EML light illuminated	OK		
ABS light illuminated	Fault
