VEHICLE INSPECTION REPORT

MC74DYA

Maxus Deliver 9 2.0 D20 150PS

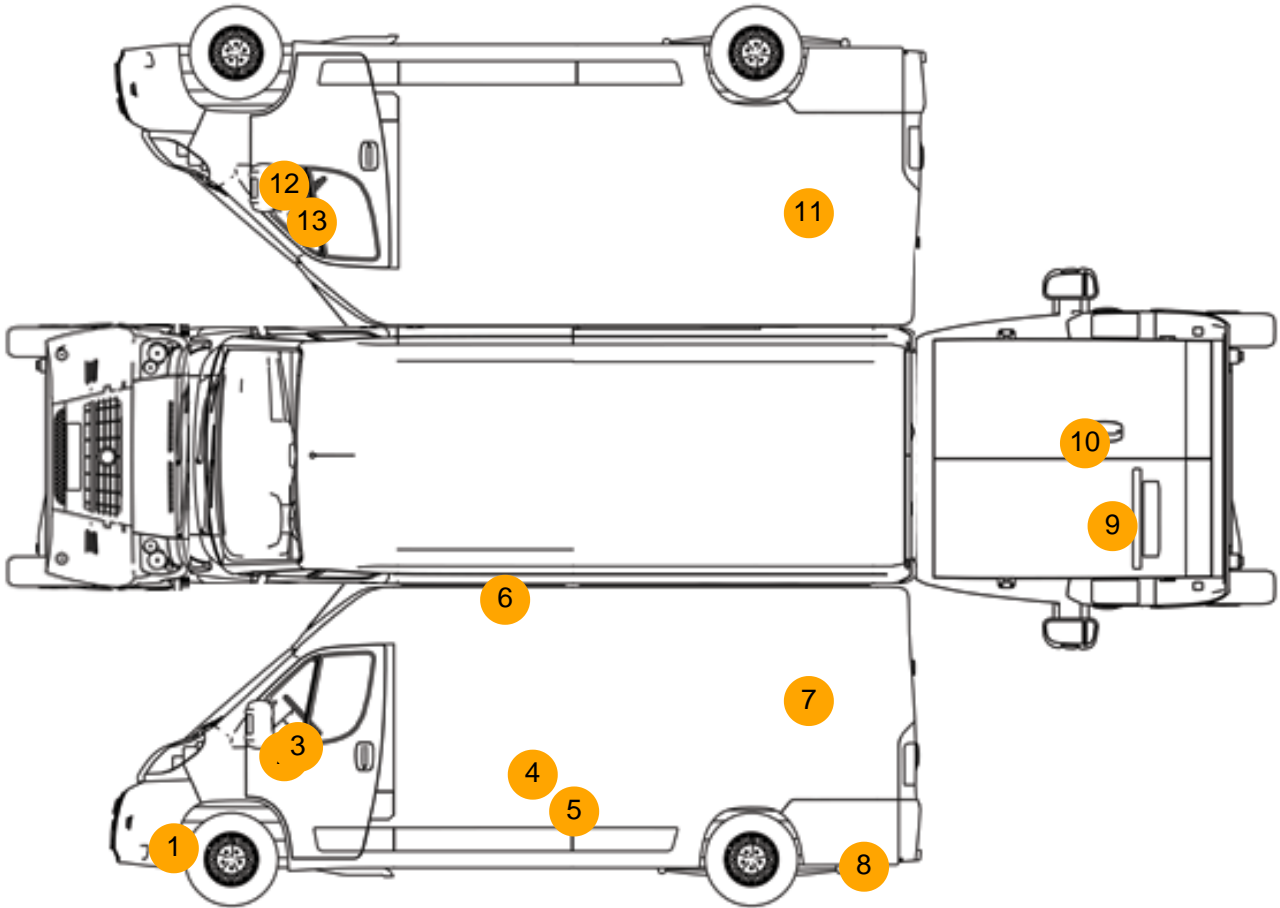
Condition Check

3: Flasher Side Repeater ns
Broken
Replace

9: Door nsr
Dented
With Paint Damage

11: Qtr Panel osr
Dented
With Paint Damage

13: Flasher Side Repeater os
Broken
Replace
