# VEHICLE INSPECTION REPORT

**PO13ECW**

## Daf LF 45.140

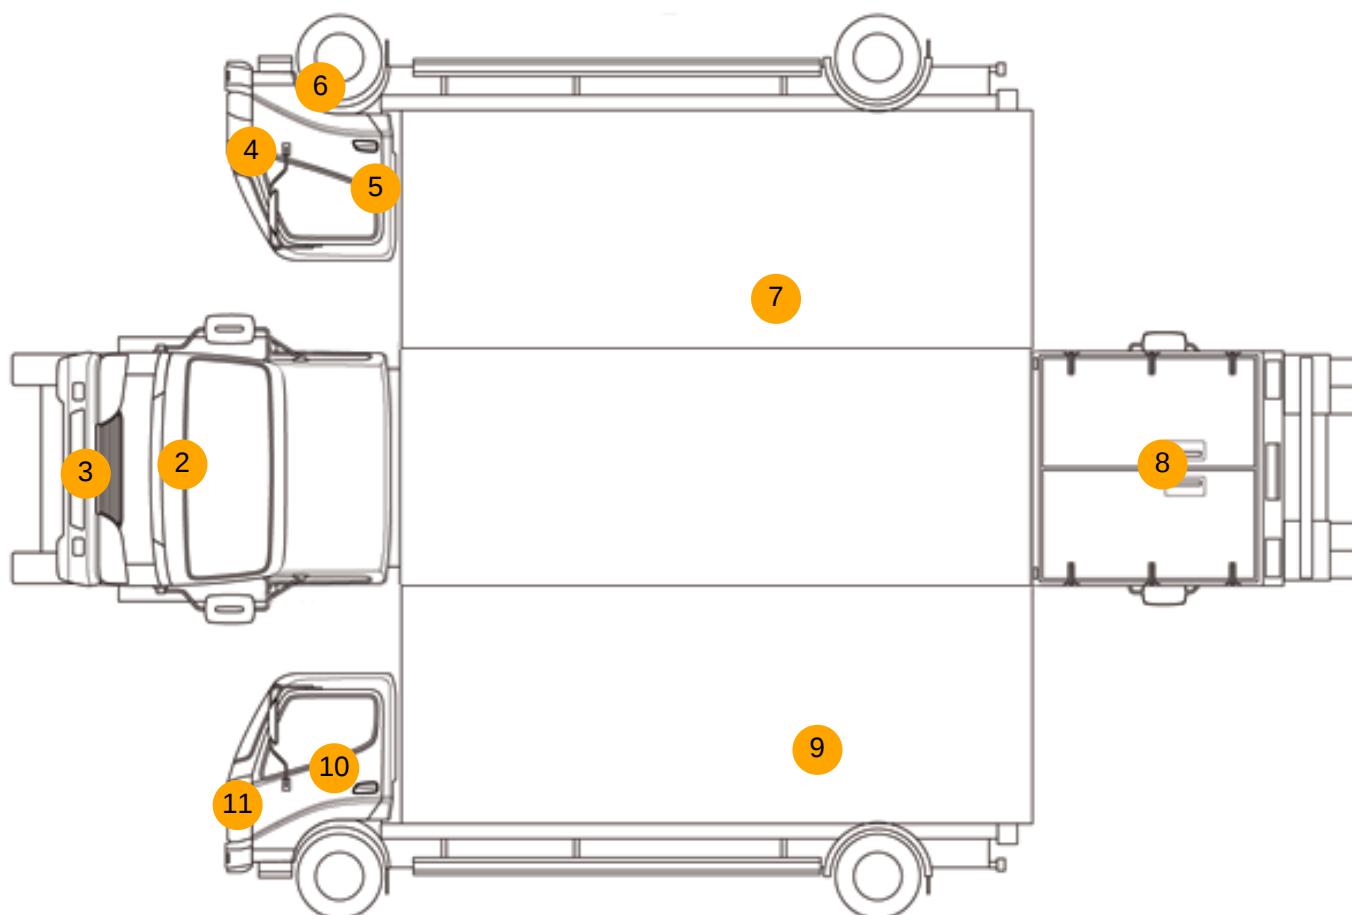
## Condition Check

3: Bumper Front  
Rusted  
Over 5mm

4: Wing osf  
Cracked  
Replace

7: Qtr Panel osr  
Rusted  
Over 5mm

8: Tailgate  
Rusted  
Over 5mm

9: Qtr Panel nsf  
Rusted  
Over 5mm

10: Door nsf  
Dented  
With Paint Damage
