VEHICLE INSPECTION REPORT

BX09FZO

Daf LF 45.180

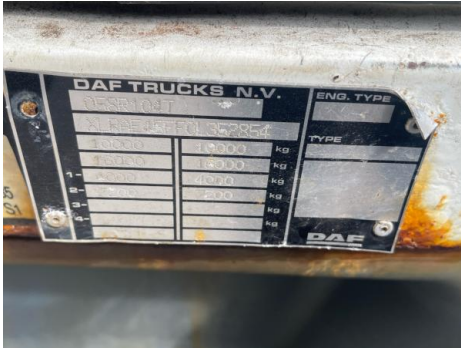
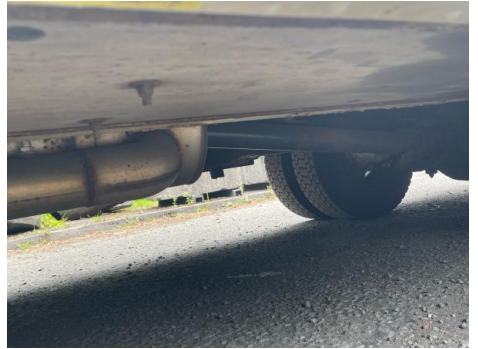
Plate		DTP Ref. No.	
BX09 FZU		006428	
Vehicle Identification No. XLR4E45F0L352854			
Model DAF /FA 4510 H184			
Year of Original Registration 24/08/09			
Year of Manufacture 2009			
Speed Limit N			
Description of Weights Applicable to vehicle			
Gross Weight 10000 10000			
Train Weight 13500 13500			
Gross Weight 13500 13500			
Train Weight 13500 13500			
Date of issue			
DEPARTMENT FOR TRANSPORT GREAT BRITAIN

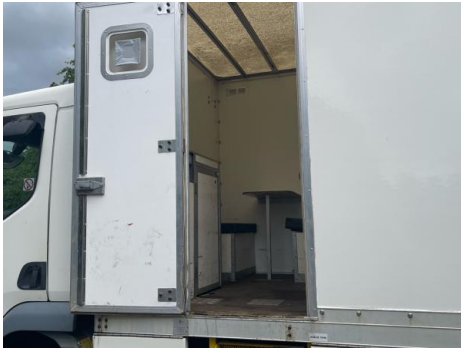
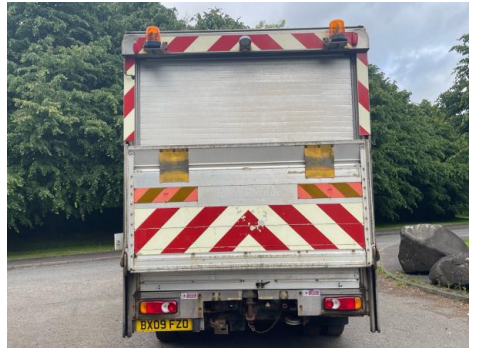
Vehicle registration number	
BX09 FZU	
Description TAIL LIFT TEST	
This equipment was Thoroughly Examined on 12/9/2023	
Signed by	S. Rennie
Printed name	S. RENNIE
THE THOROUGH EXAMINATION REPORT FOR THIS EQUIPMENT EXPIRES ON THE DATE SHOWN BELOW:	
11/3/2024	
THE EQUIPMENT MUST NOT BE USED AFTER THIS DATE.	
A copy of the full Examination report can be obtained by:	
Telephone: 0870 8204328 Option 2
