# VEHICLE INSPECTION REPORT

**SG13OFM**

## Peugeot Bipper 1.3 HDi 75PS S

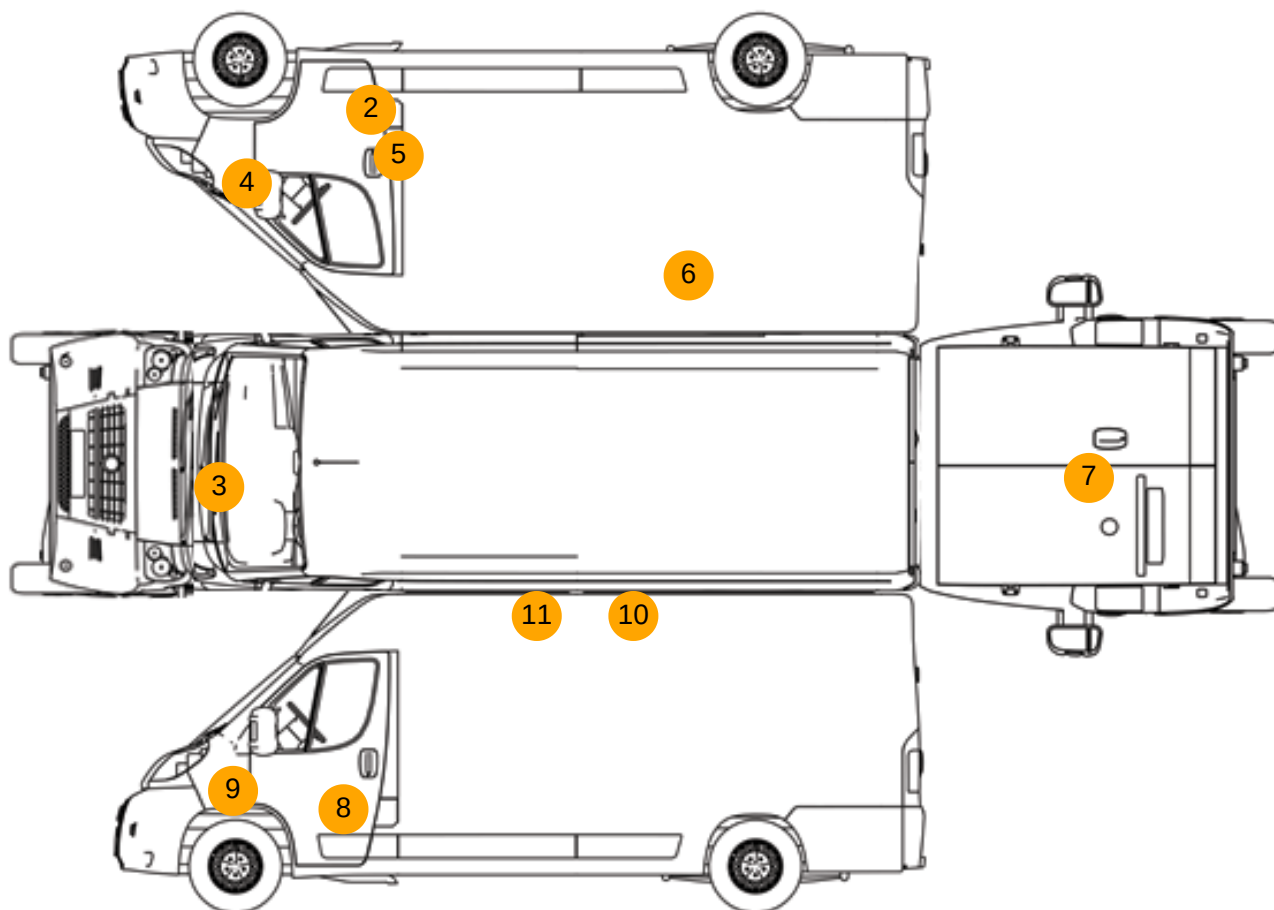
## Condition Check

2: Sill os  
Rusted  
Over 5mm

4: Wing osf  
Rusted  
Over 5mm

7: Tailgate  
Dented  
With Paint Damage

8: Door nsf  
Rusted  
Over 5mm

9: Wing nsf  
Dented  
With Paint Damage

10: Door nsr  
Dented  
With Paint Damage

11: Roof  
Dented  
With Paint Damage
