# VEHICLE INSPECTION REPORT

**YJ69ZTV**

## Mercedes-Benz Actros 2543

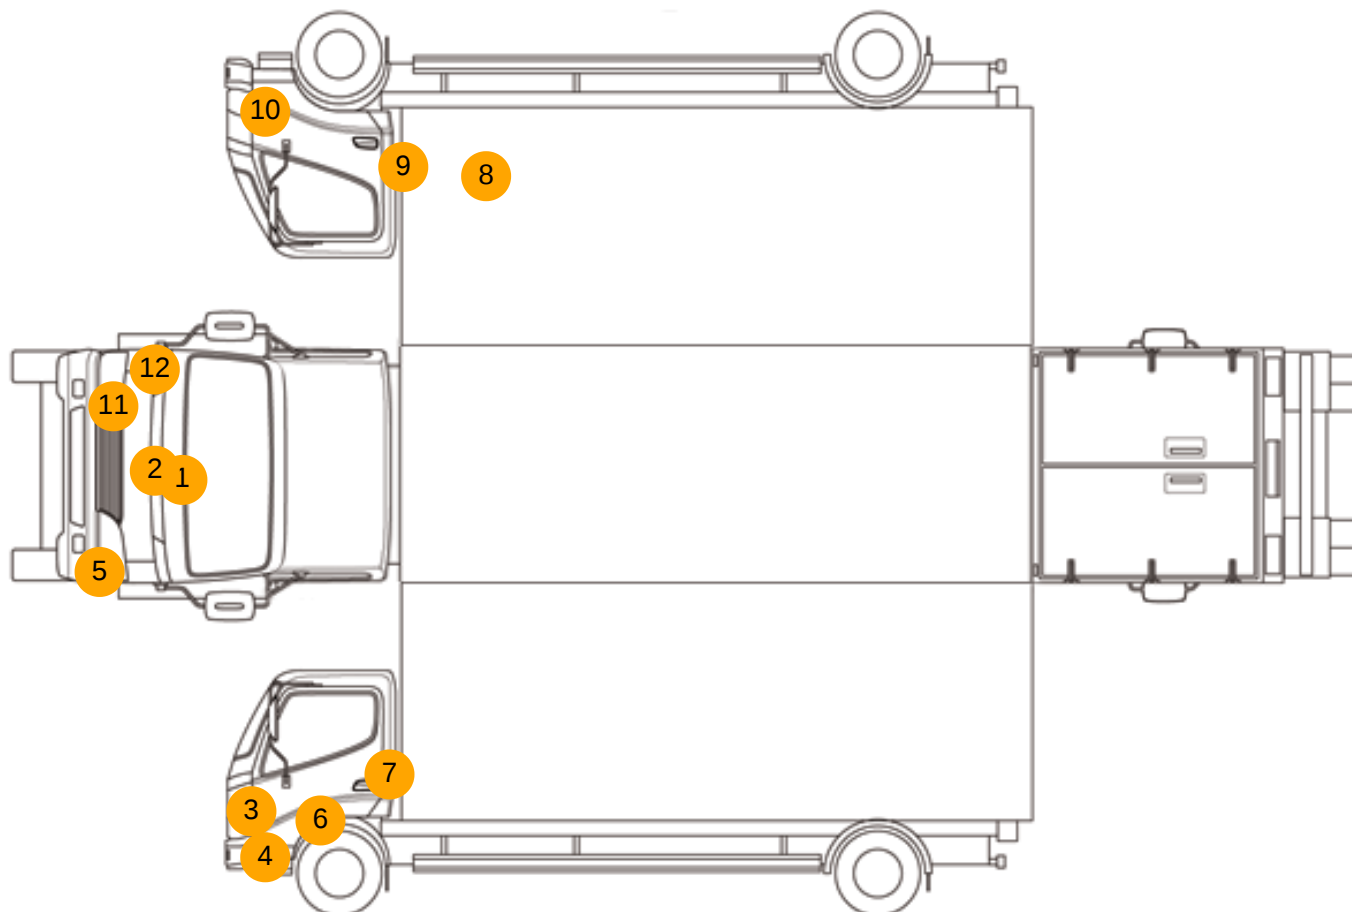
## Condition Check

2: Badgedecal Front  
Missing  
Replace

4: Bumper Front Moulding  
Missing  
Replace

10: Bumper Front Moulding  
Missing  
Replace
